VERIFICATION REQUIREMENTS FOR COVER SYSTEMS

Technical Guidance for Developers,
Landowners and Consultants

Yorkshire and Lincolnshire Pollution Advisory Group

Version 4.1 - June 2021

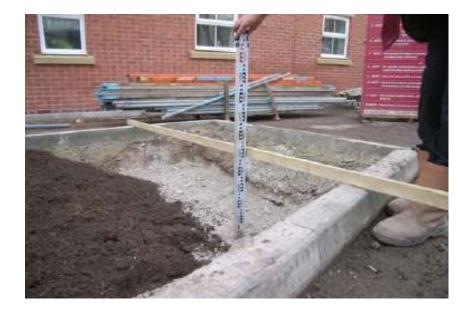
Photograph 1:
Depth check of inert cover within area of public open space.
Physical break layer and topsoil visible.

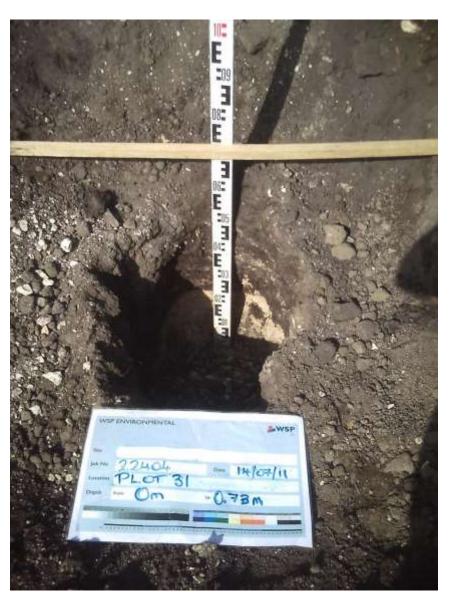
Photograph 2: Depth check of inert cover with Site & Location Information Board.

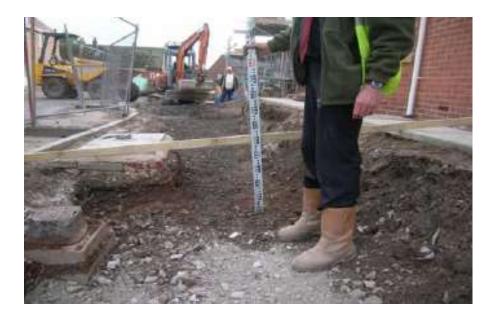
Photograph 3: Depth check of inert cover within areas of front gardens.

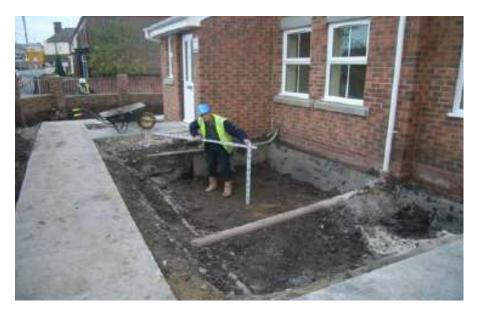
Photograph 4: Depth check of inert cover within areas of front gardens.

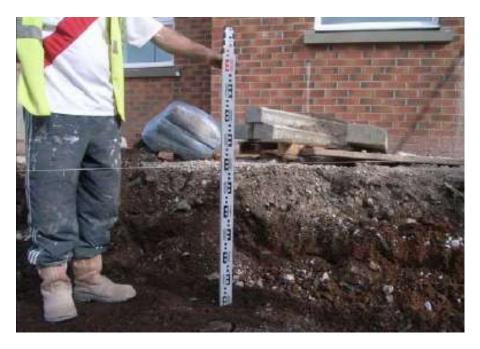
Photograph 5: Depth check of inert cover within rear gardens. Taut string line spans across excavation.

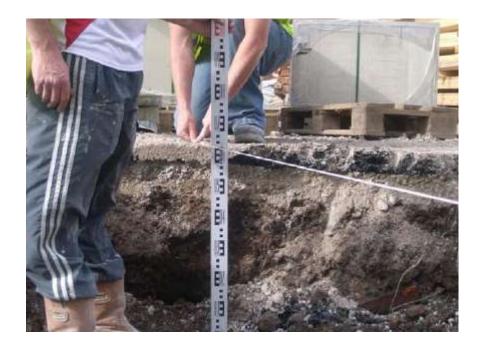
Photograph 6: Depth check of inert cover within rear gardens. Taut string line spans across excavation.

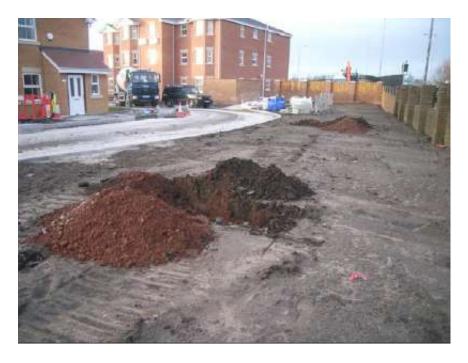
Photograph 7: Shows the spatial location of the verification pit.

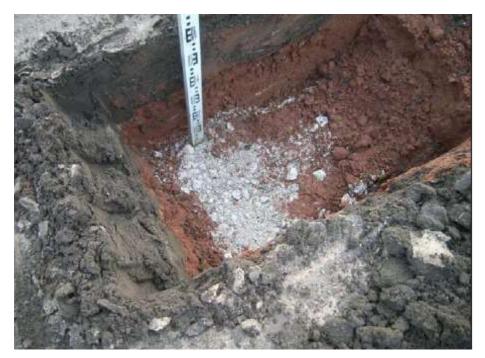
Photograph 8:
Excavation within public open space and verification pit showing the presence of a remediation break layer at the base, a crushed sandstone inert fill overlain by topsoil.

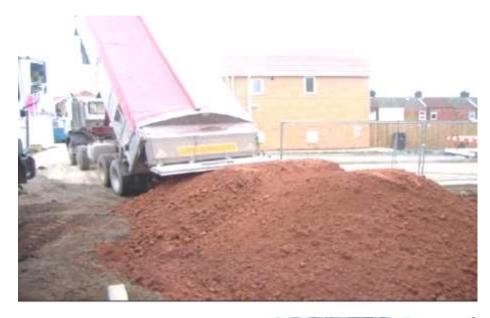
Photograph 9: Inert crushed sandstone being delivered. The spatial area of the remediation can be observed from these photographs (old terrace housing).

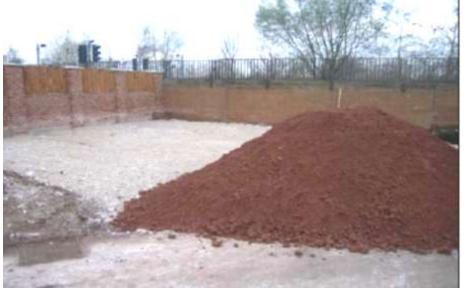
Photograph 10: Inert crushed sandstone being delivered with visible remediation break layer. The spatial area of the remediation can be observed from these photographs (traffic lights).

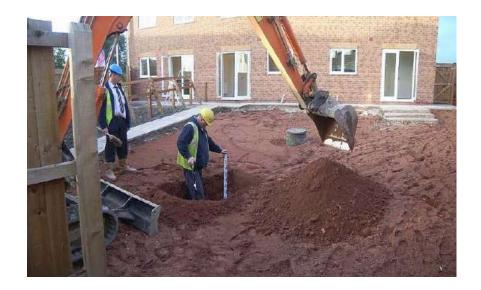
Photograph 11:
Shows the remediation of the rear garden, with a significant depth (1.0m) of inert cover. This photograph has been stitched to form a panoramic photograph and hence there is slight distortion

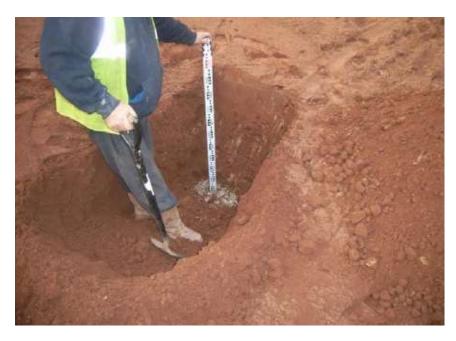
Photograph 12: Shows the remediation of the rear garden, with a significant depth (1.0m) of inert cover. Remediation break layer visible at the base of the excavation.
