# this is Loftus Conservation Area Appraisal 2023

# 1. Introduction

## The Designation of Loftus Conservation Area

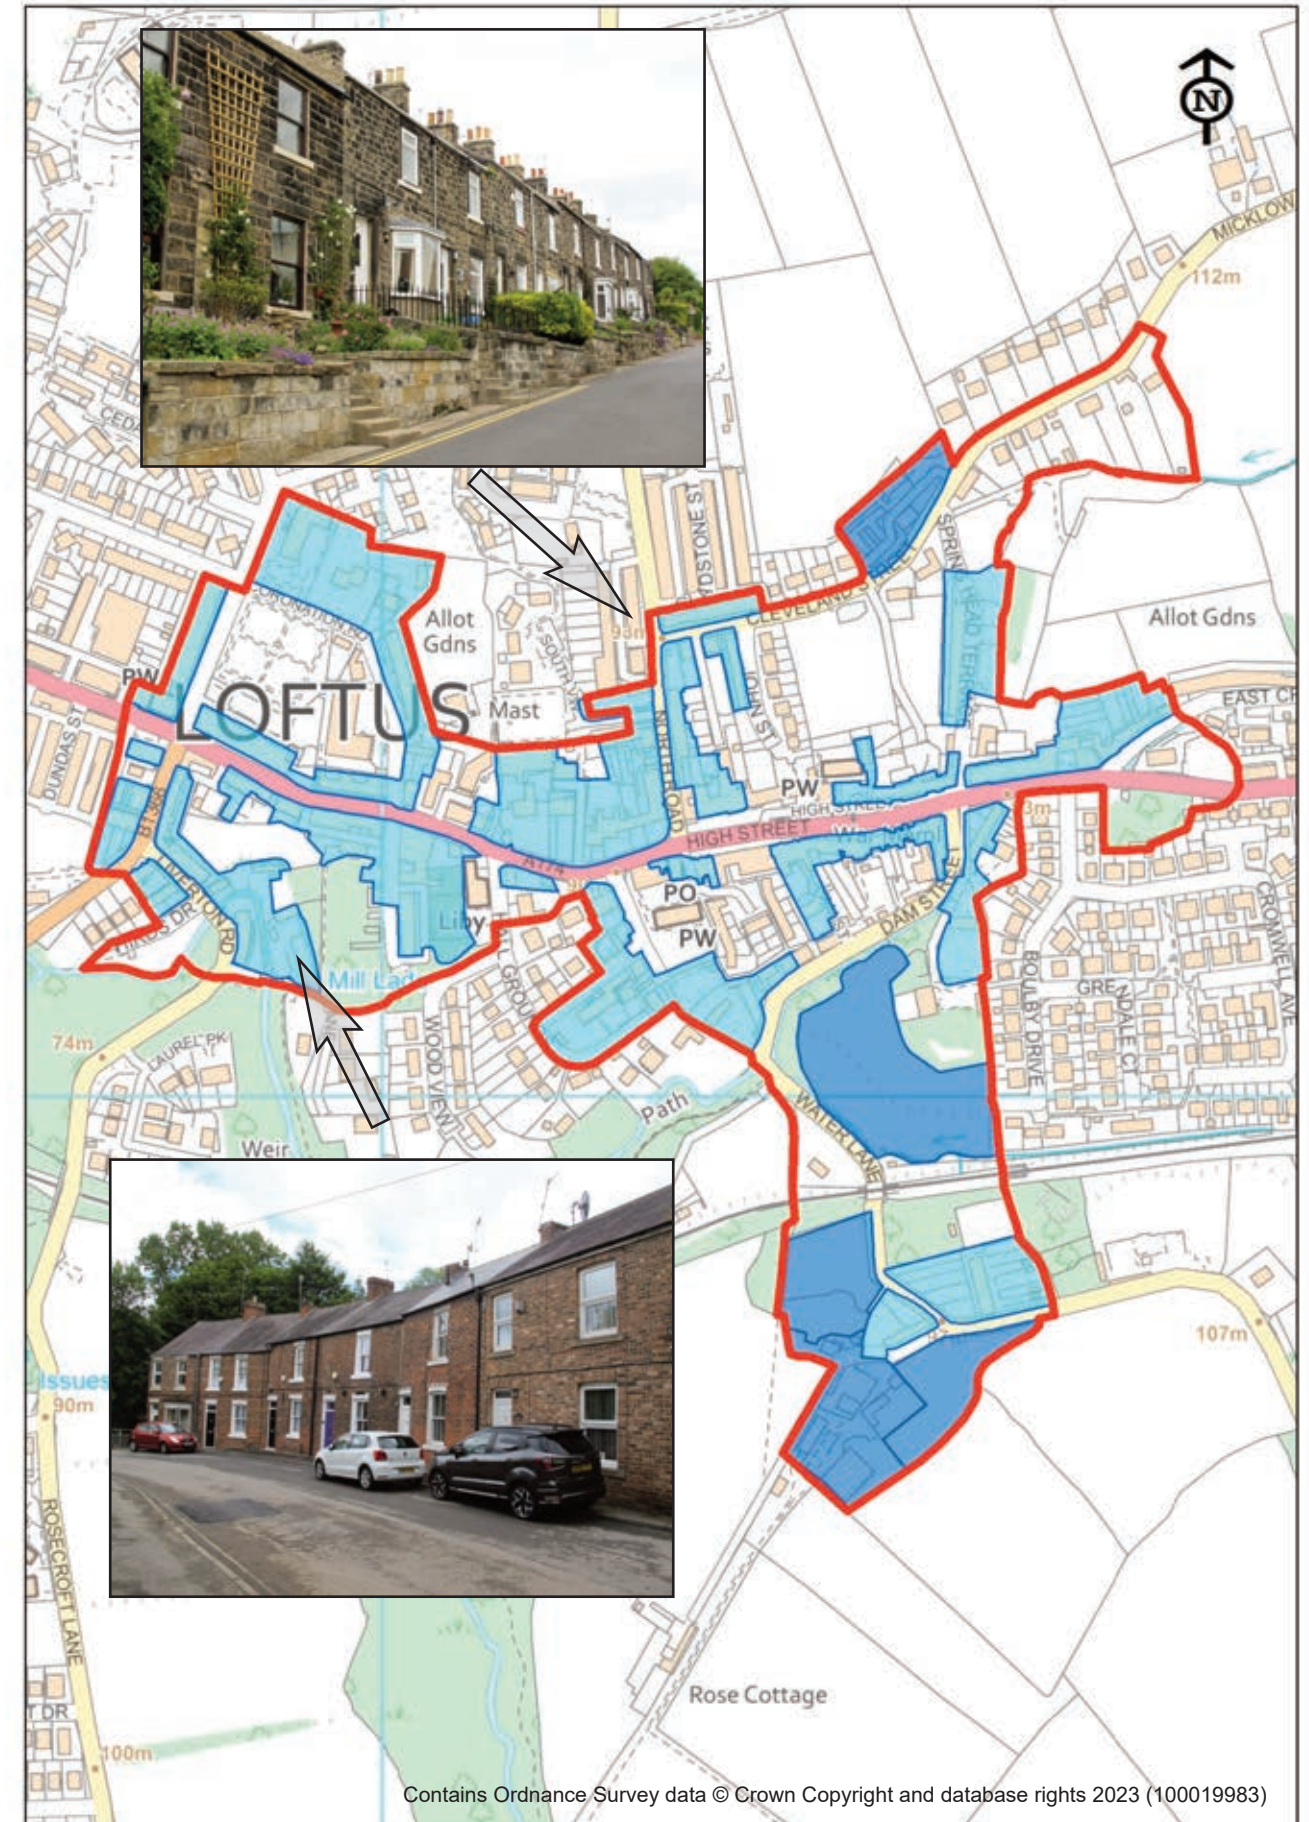
ARTICLE IV DIRECTIONS

- 1.9 Much of the conservation area is covered by Article 4 Directions, which were approved by the Secretary of State for the Environment on 8<sup>th</sup> September 1978. The directions withdraw certain permitted development rights for domestic, commercial and agricultural properties throughout the conservation area, the intention of these restrictions being to protect its special character.
- 1.10 Regrettably, since that designation it is apparent that the imposed restrictions have frequently been breached resulting in a subsequent loss of character. The extent to which this has occurred is assessed and quantified in the accompanying Conservation Area Management Plan.

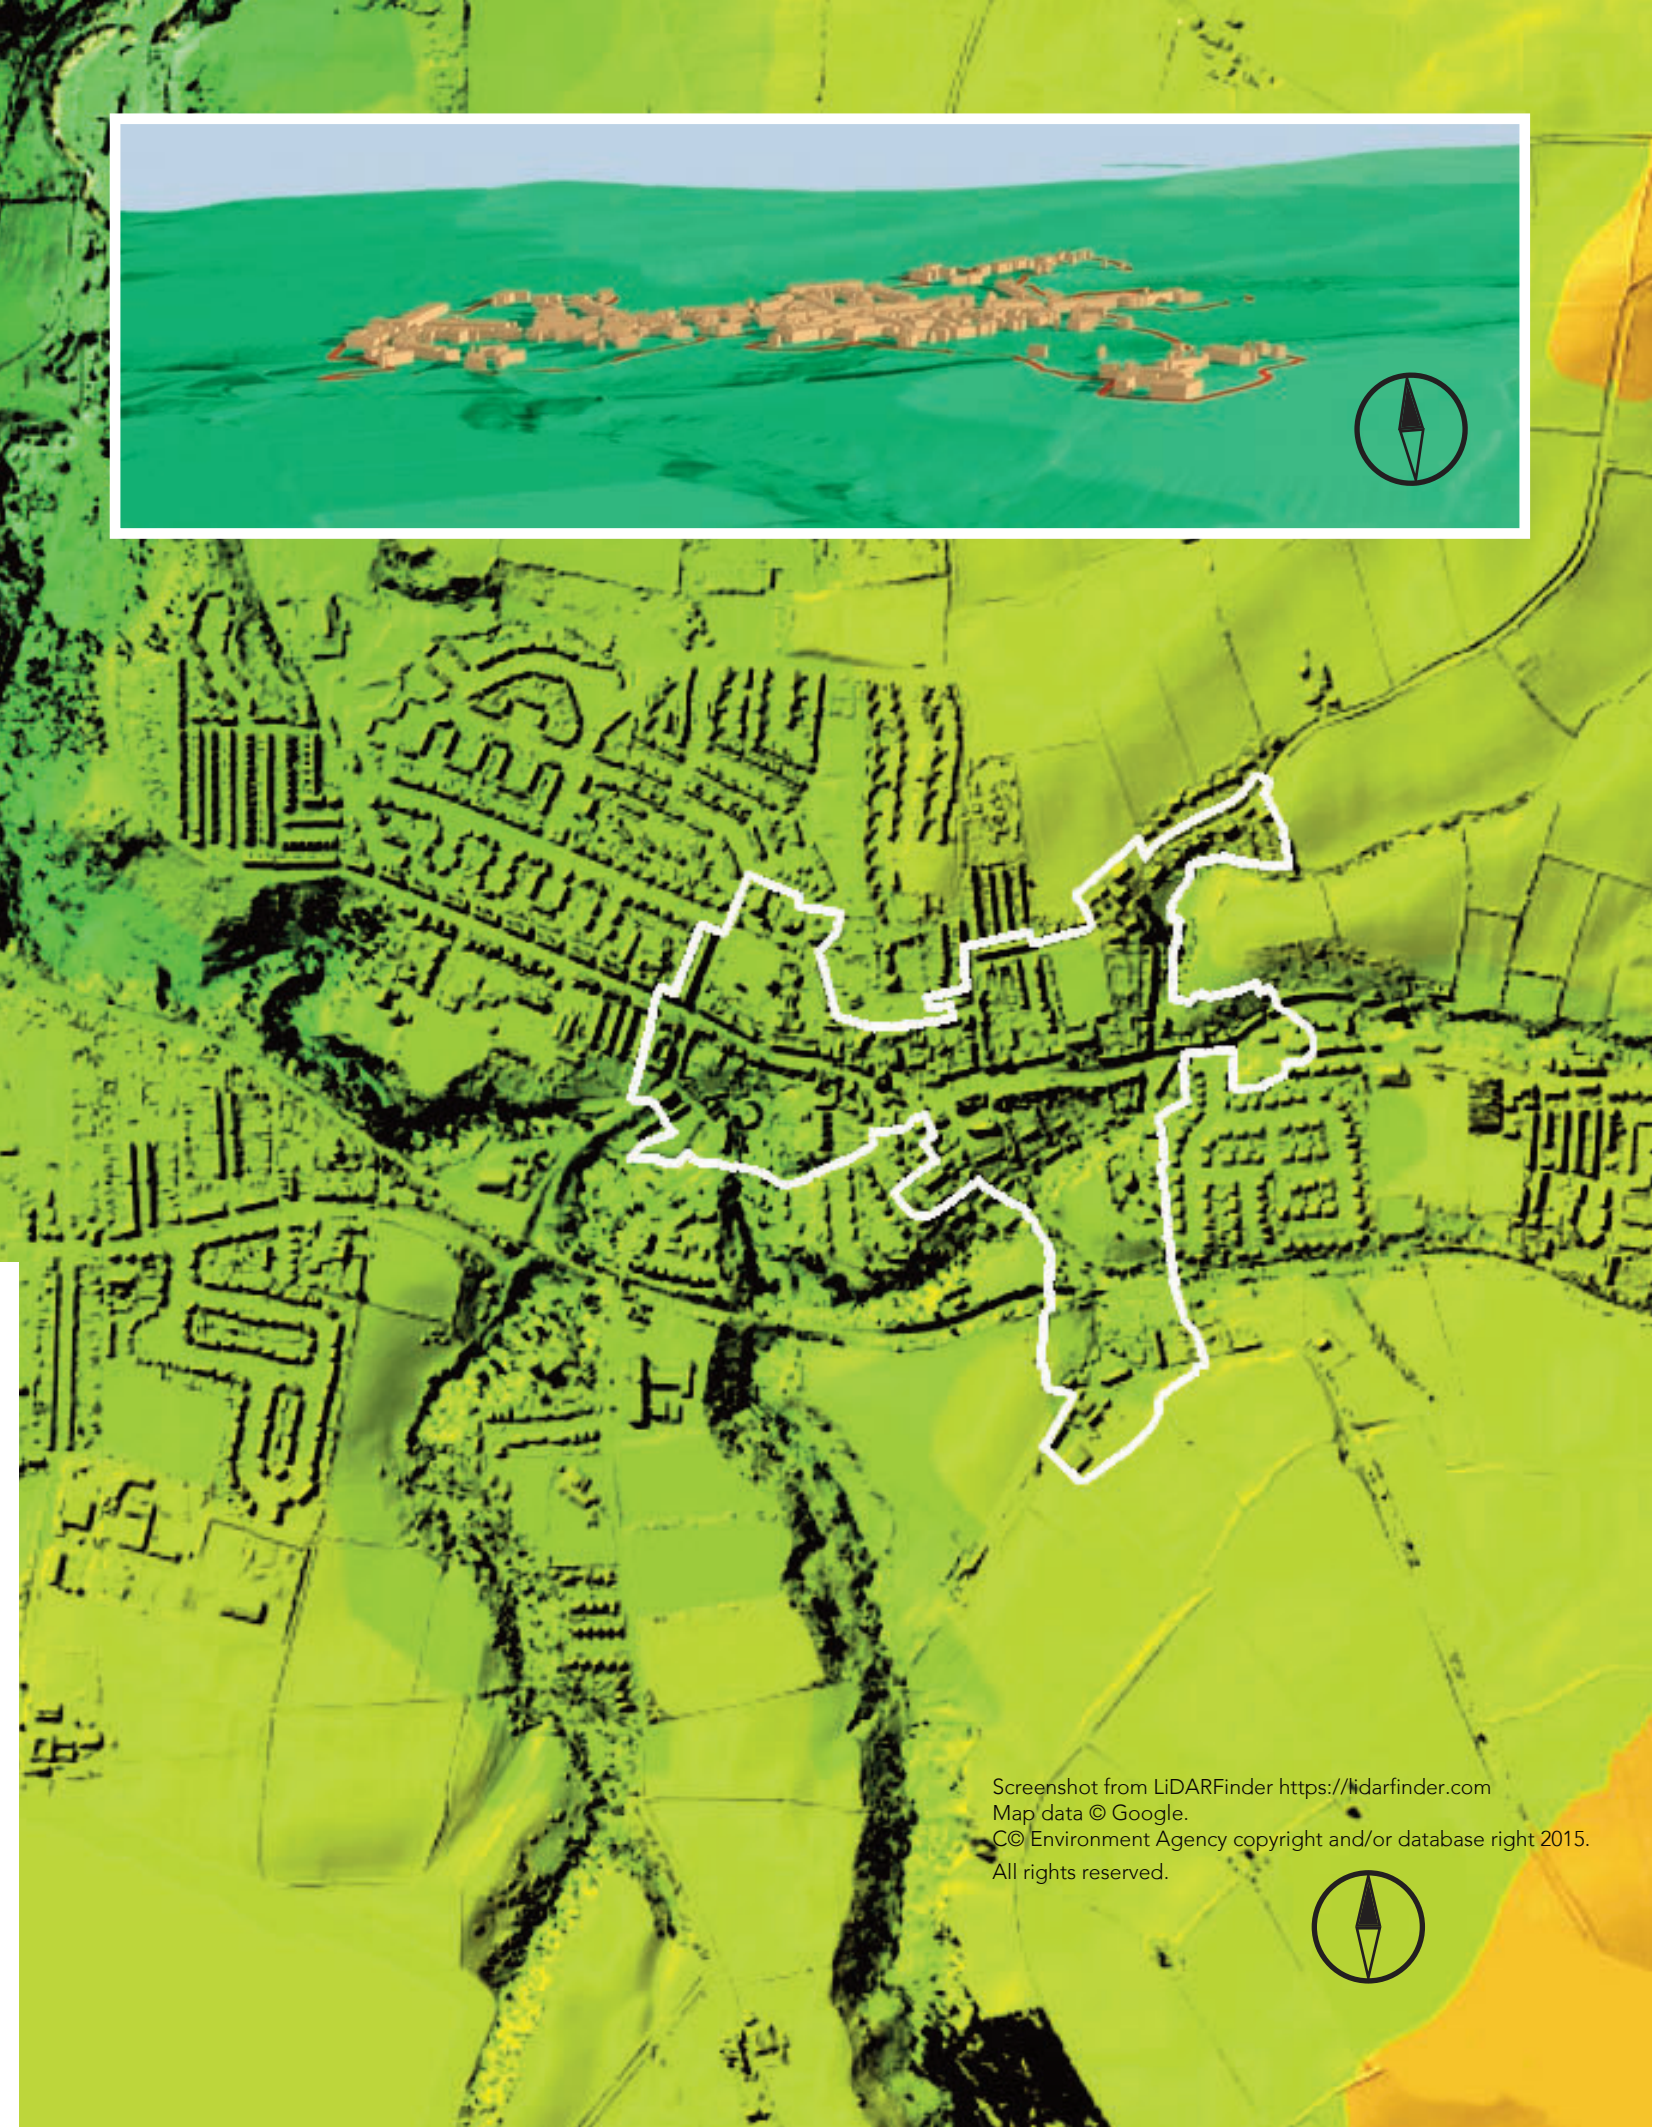
- 2.2 Much of the character and visual quality of Loftus can be attributed to its physical setting amid rolling hill country incised by numerous small streams or becks, creating a series of deep, narrow, wooded ravines or gills. This variation in topography results in considerable visual interest and elements of surprise to the built fabric of the town, creating a succession of varying street scenes. The wooded valleys provide an attractive landscape setting to the town, where streetscapes and roofscapes are frequently viewed against a backdrop of trees and surrounding hillsides, softening the skyline and engendering a sense of proximity to the countryside.

- 2.3 Changes in level within the conservation area have given rise to distinctive 'split level' streets where one side is high than the other, supported by a bank or retaining wall. Examples are to be seen in the High Street, Zetland Terrace, Station Road and Dam Street.
- 2.4 The area's natural, physical and geological features have influenced the character of the built environment. This is especially noticeable in the common use of sandstone from which many buildings and walls are constructed, so characteristic of the area. In the 19<sup>th</sup> century the development of the railways brought an end to dependence on indigenous materials and gave access to an eclectic range of building materials from diverse and distant sources, including roofing slates from Cumbria and North Wales and varieties of brick.

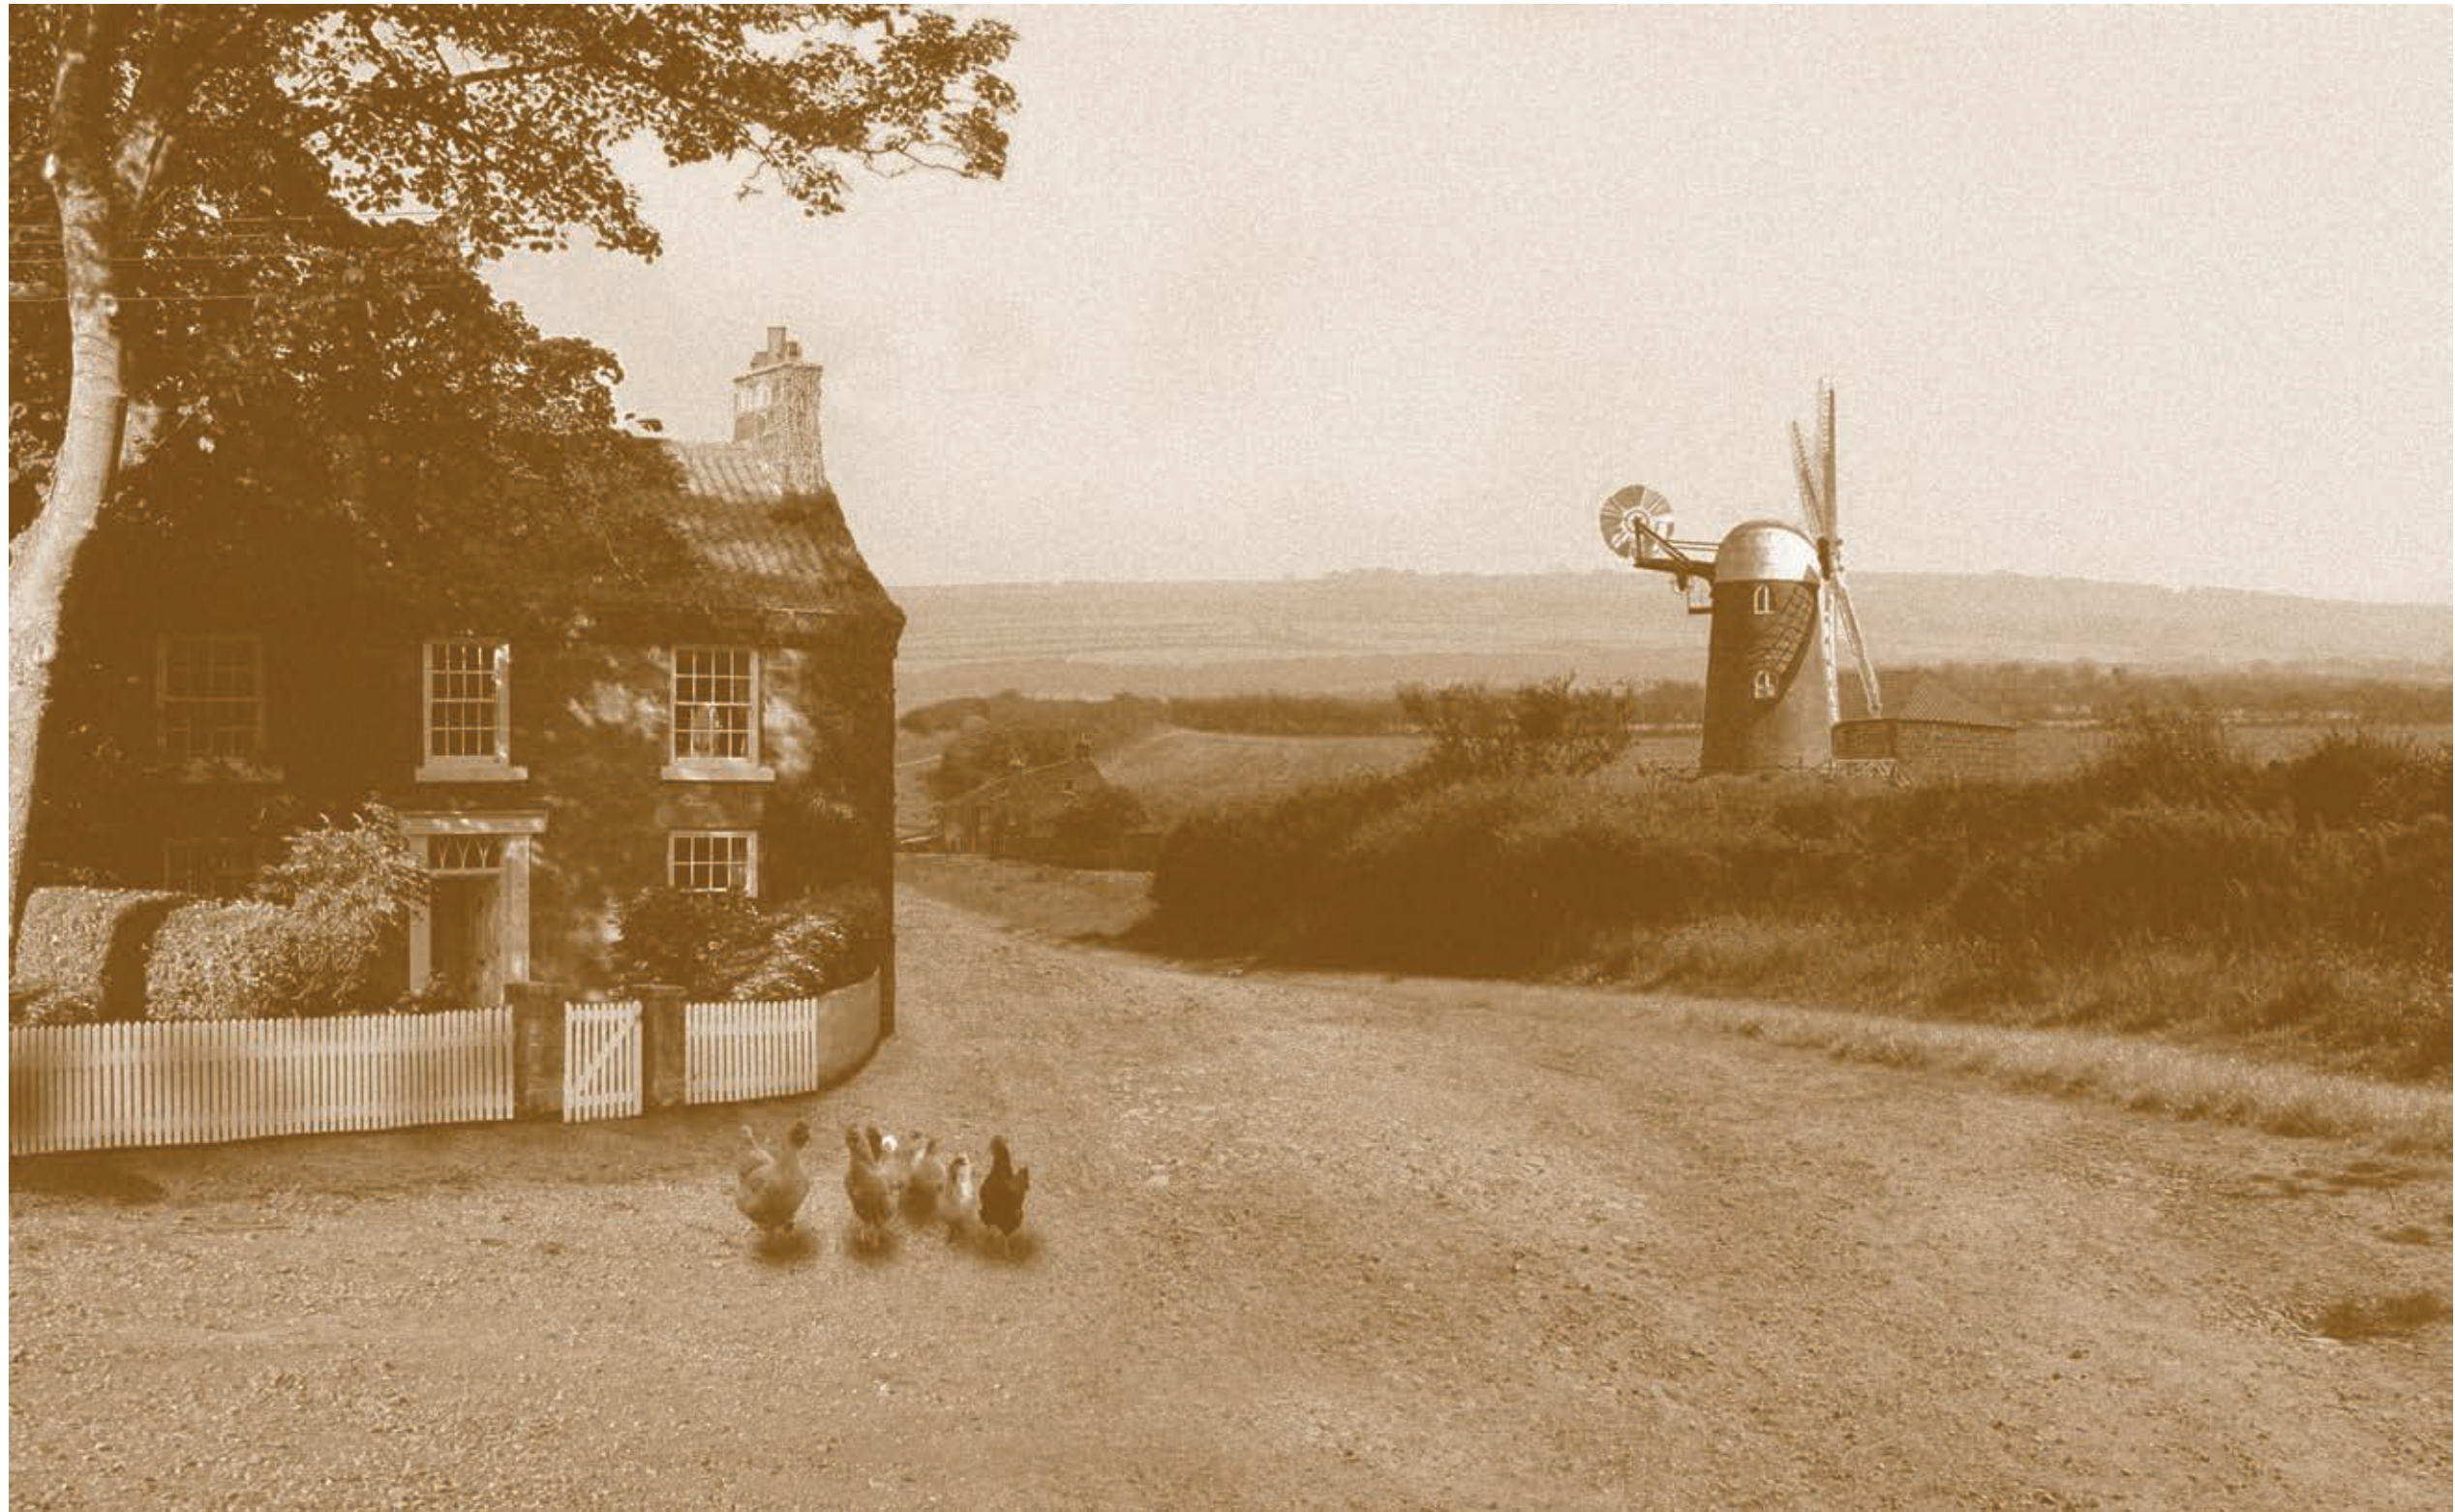
3.18 Photomontage of Jessamine Cottage created to show how the outskirts of Loftus including the former windmill may have appeared before the 19<sup>th</sup> century development of Zetland Road.

Photographs used to produce the image - Jessamine Cottage, Loftus High Street; near Ellerby and the Toll Road, Egton Bridge.

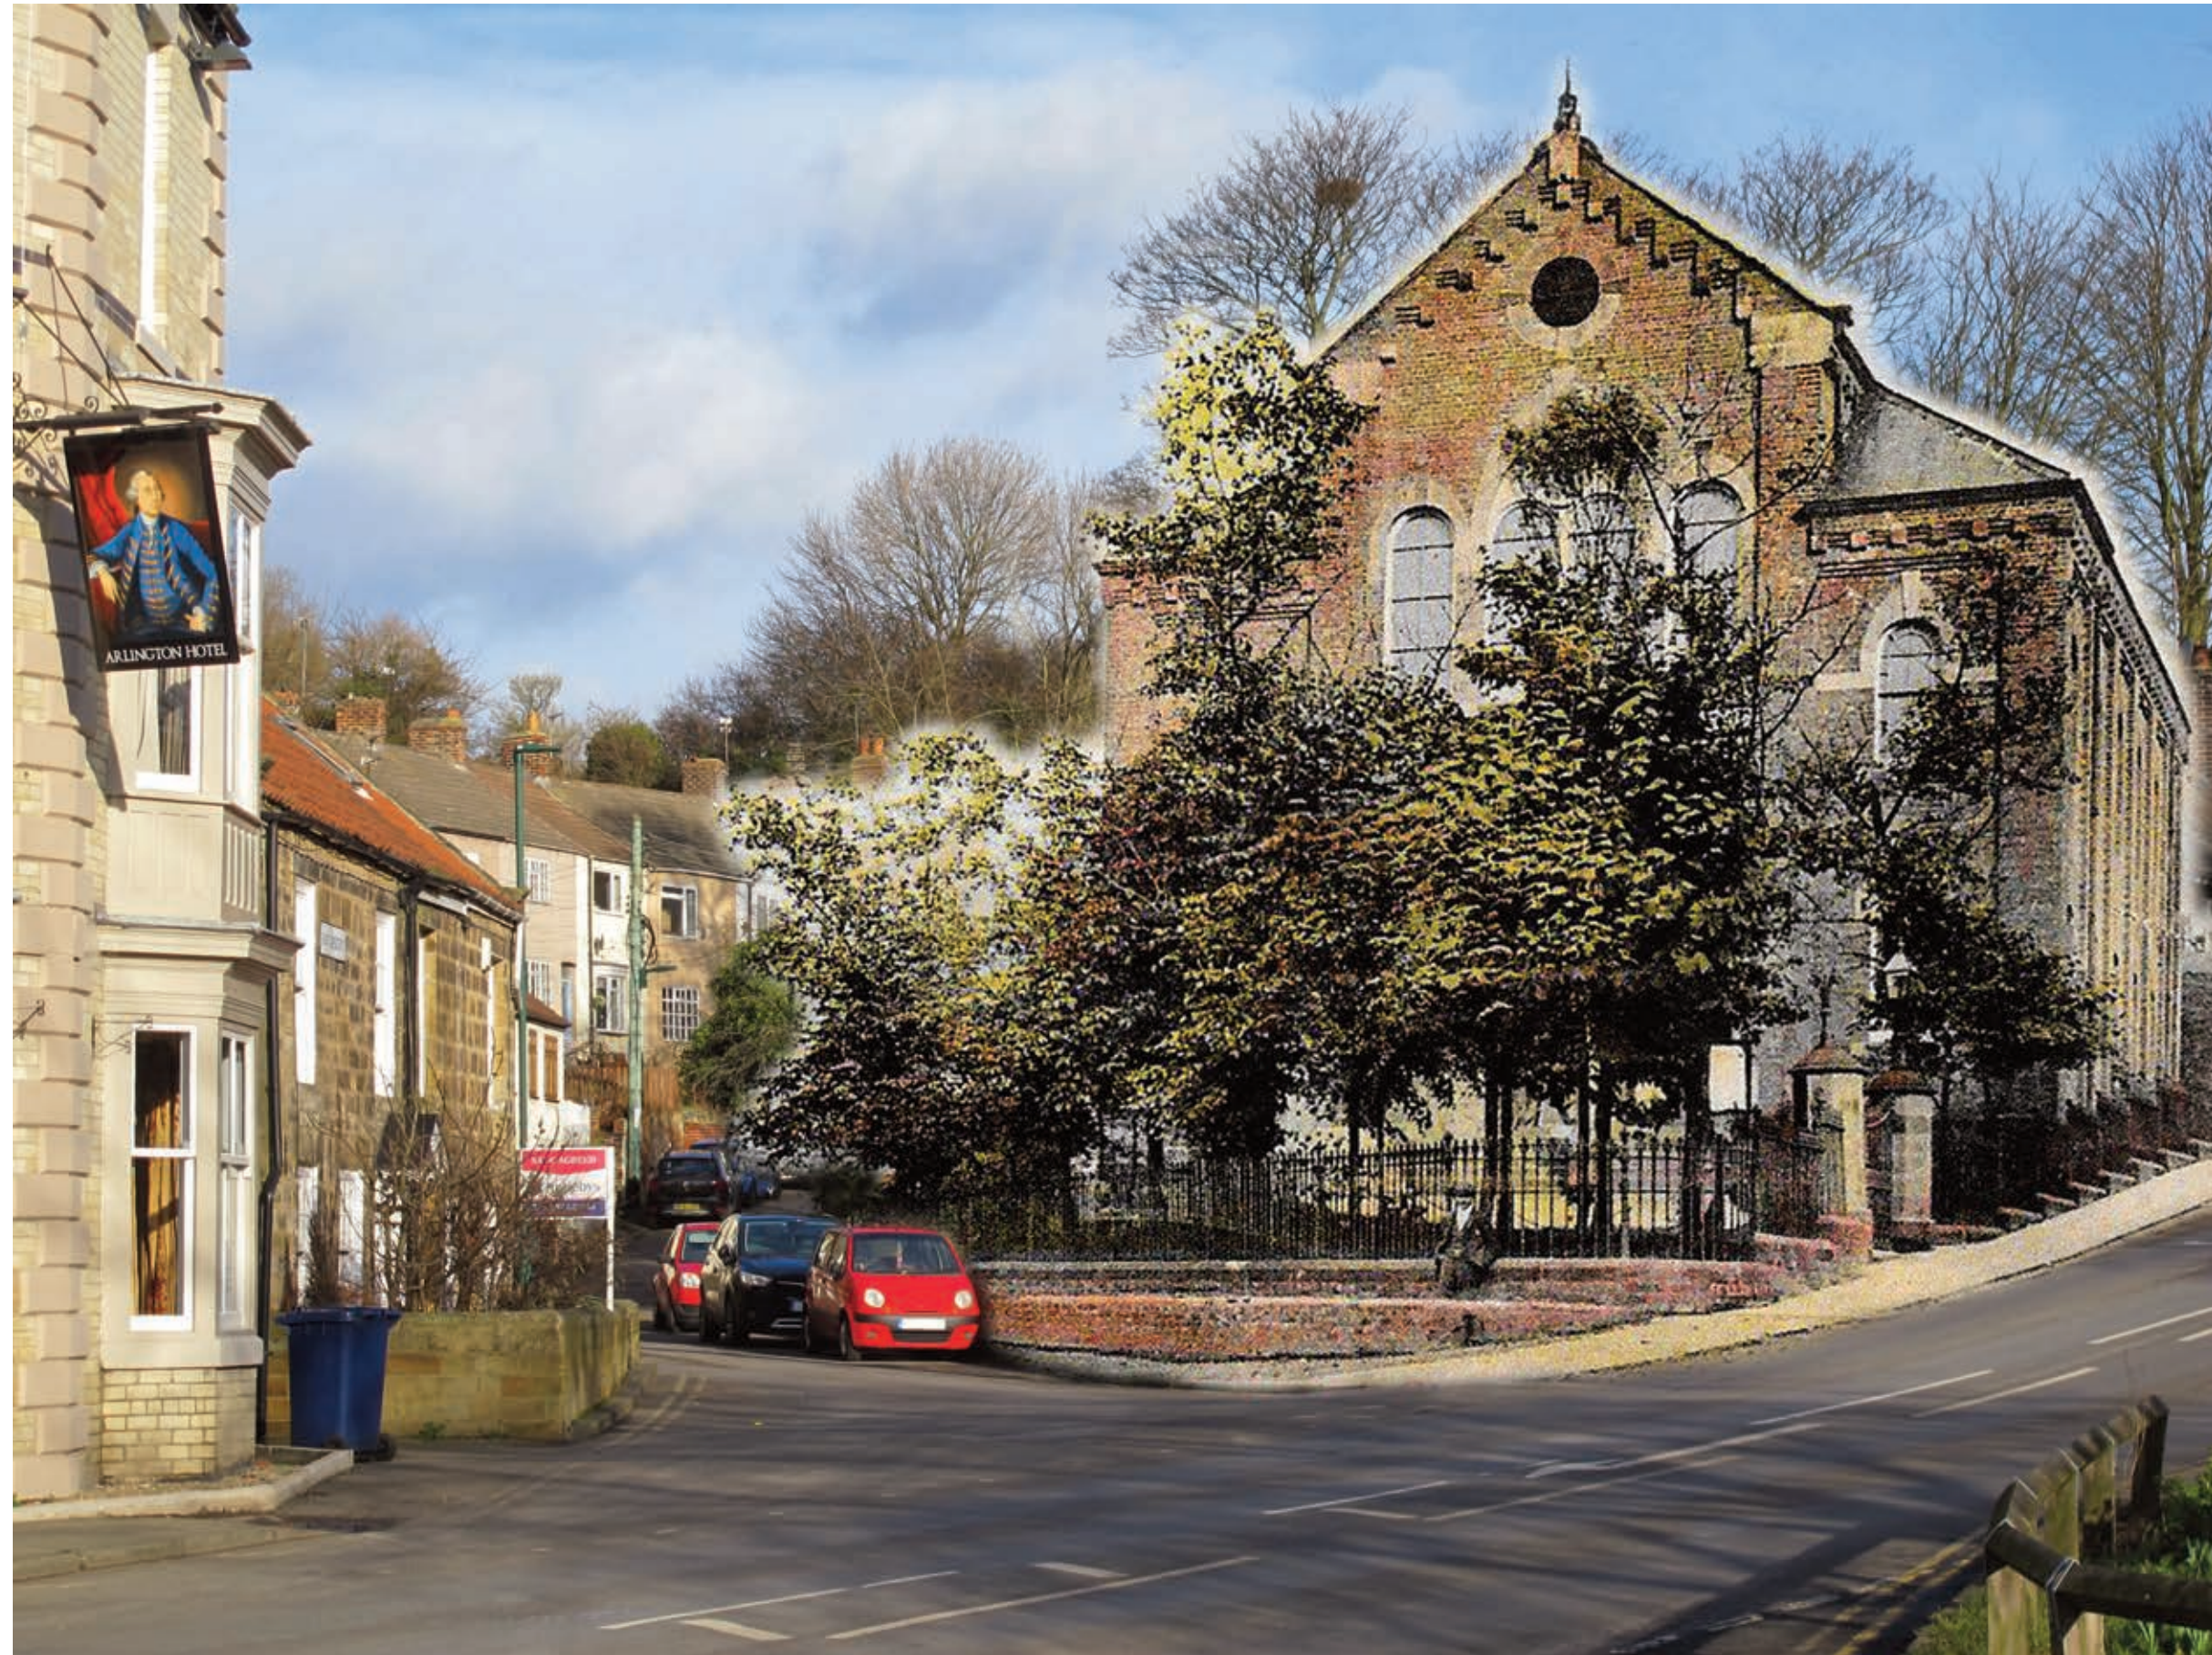
A lost key building on the edge of the Conservation Area. Newton Memorial Chapel was built in 1876 and was demolished after being hit by a Luftwaffe bomb in 1941. The graveyard remains behind the house that now occupies the plot.

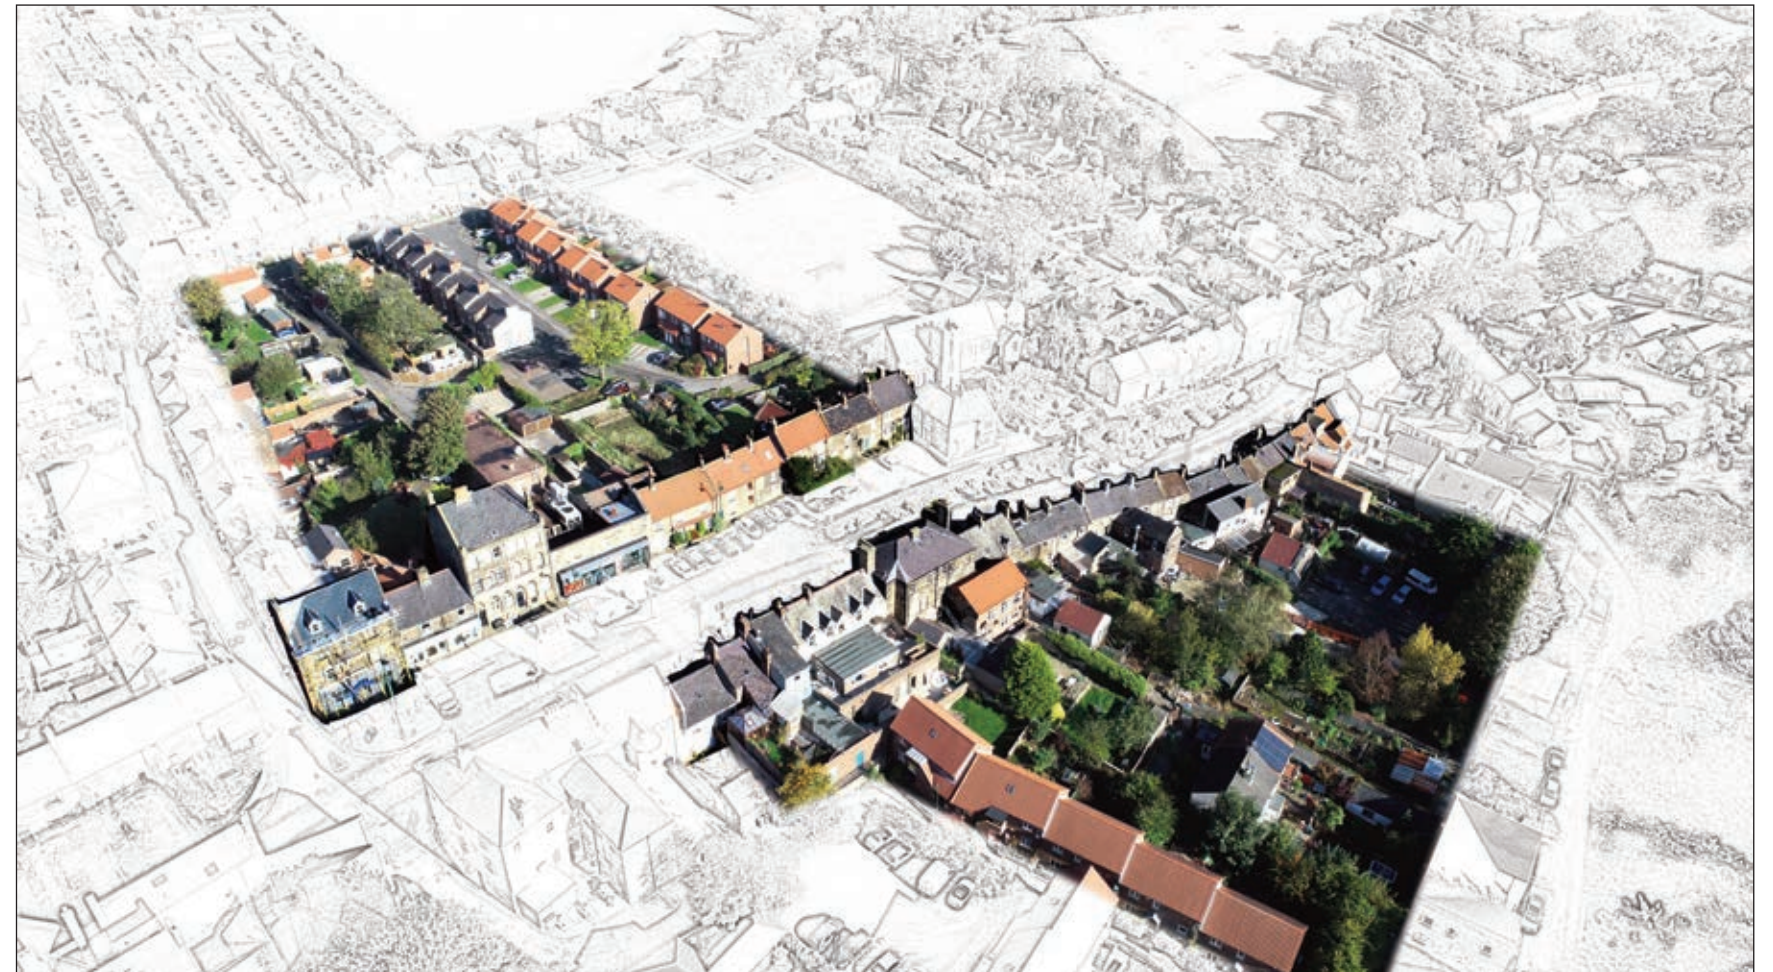
Historic 2 row core

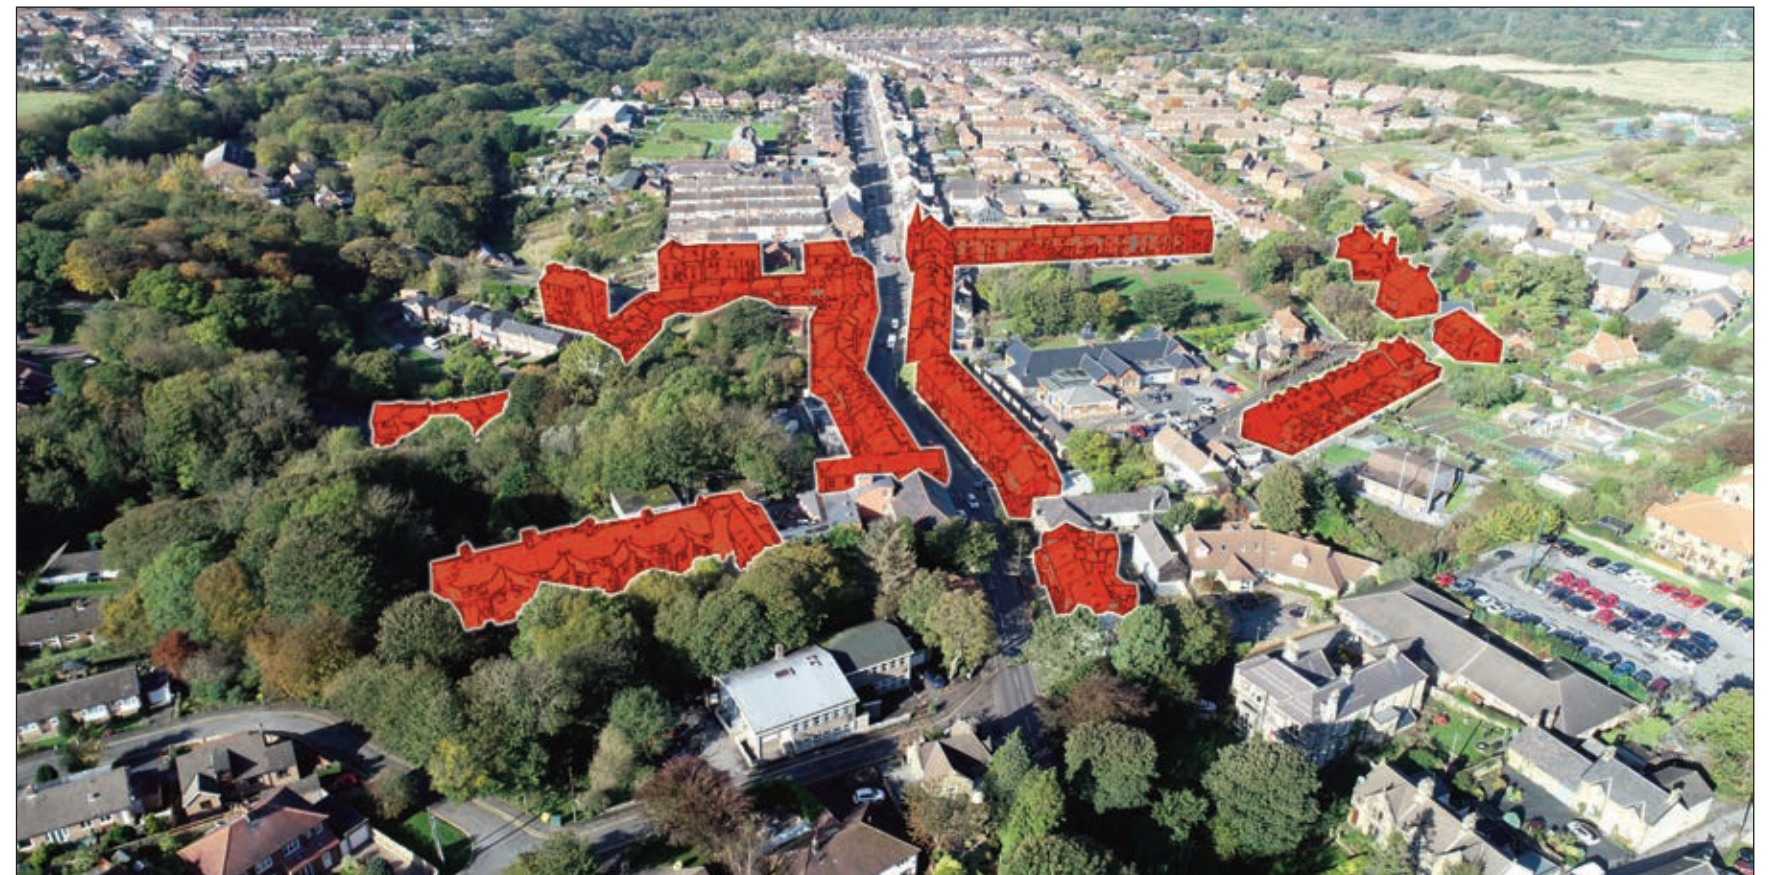
Regimented terraces of western expansion

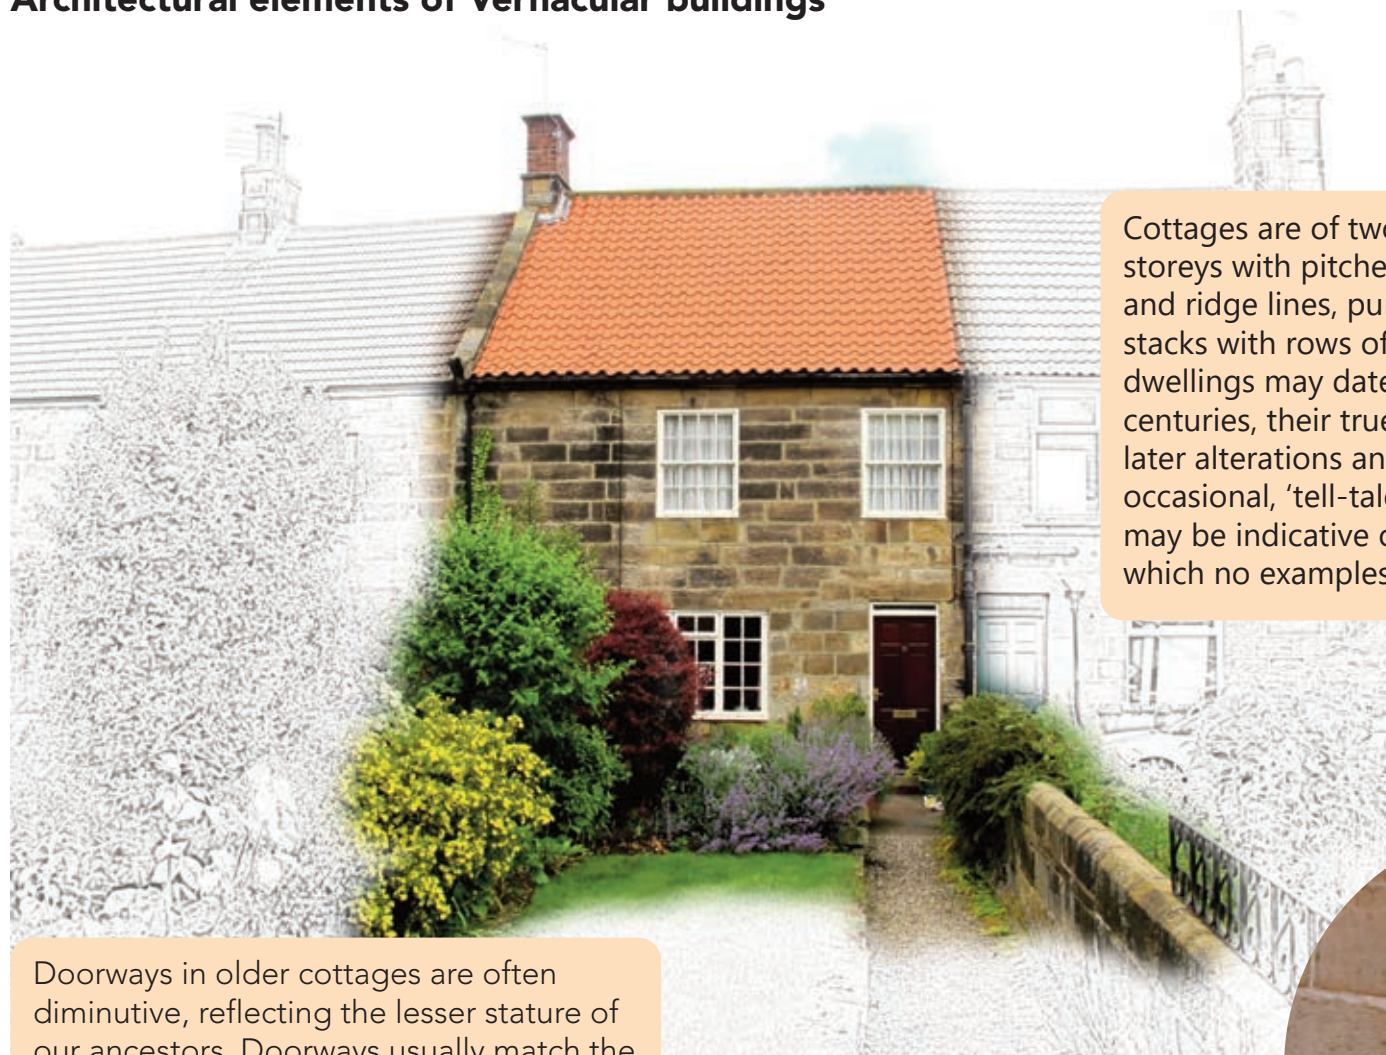
Cottages are of two and less frequently three storeys with pitched roofs and varied eaves and ridge lines, punctuated by chimney stacks with rows of clay pots. The earliest dwellings may date back three or more centuries, their true age concealed behind later alterations and additions. The occasional, 'tell-tale', steeply-pitched roof may be indicative of the past use of thatch, of which no examples survive.

Doorways in older cottages are often diminutive, reflecting the lesser stature of our ancestors. Doorways usually match the window openings by having similar lintels.

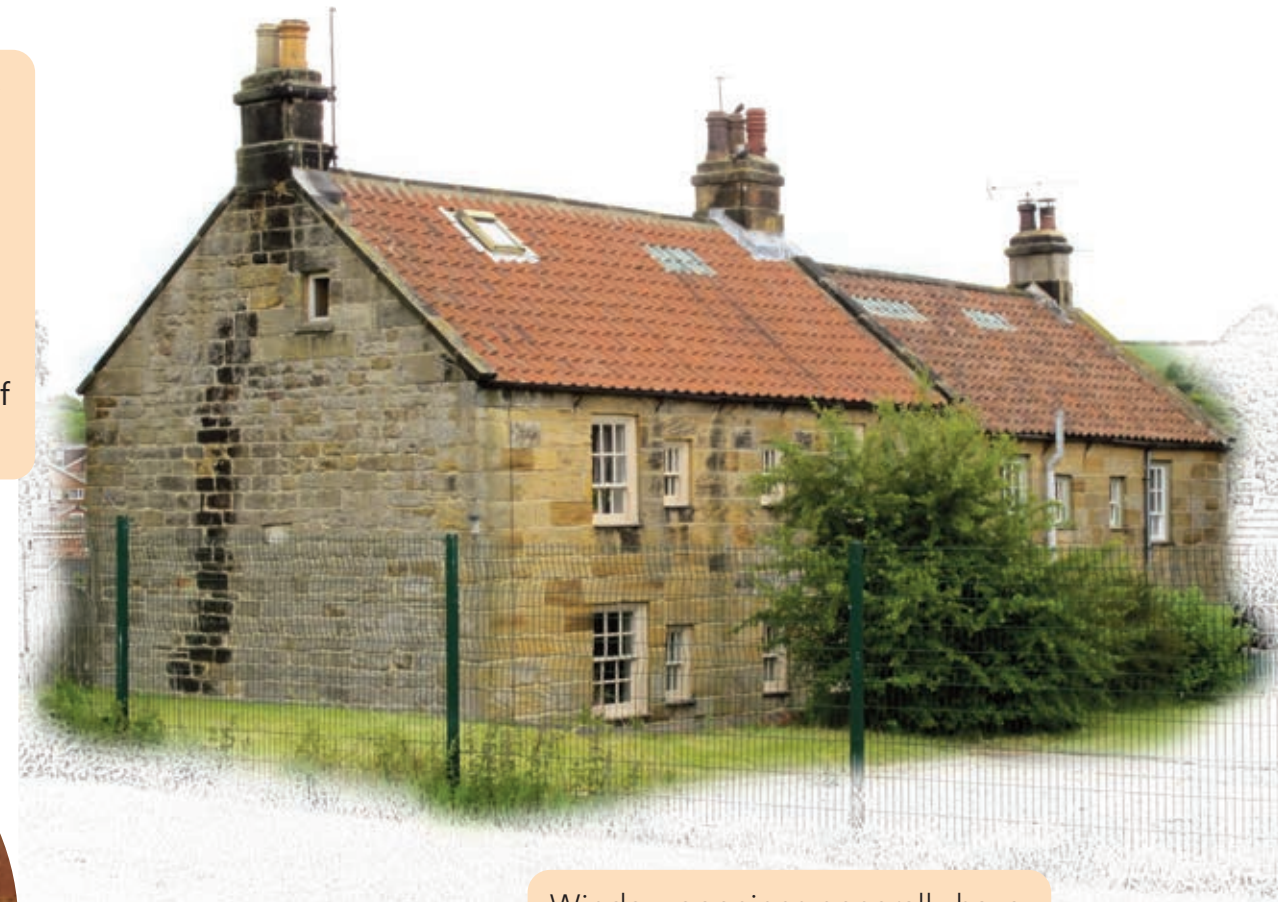
Window openings generally have stone sills and stone lintels.

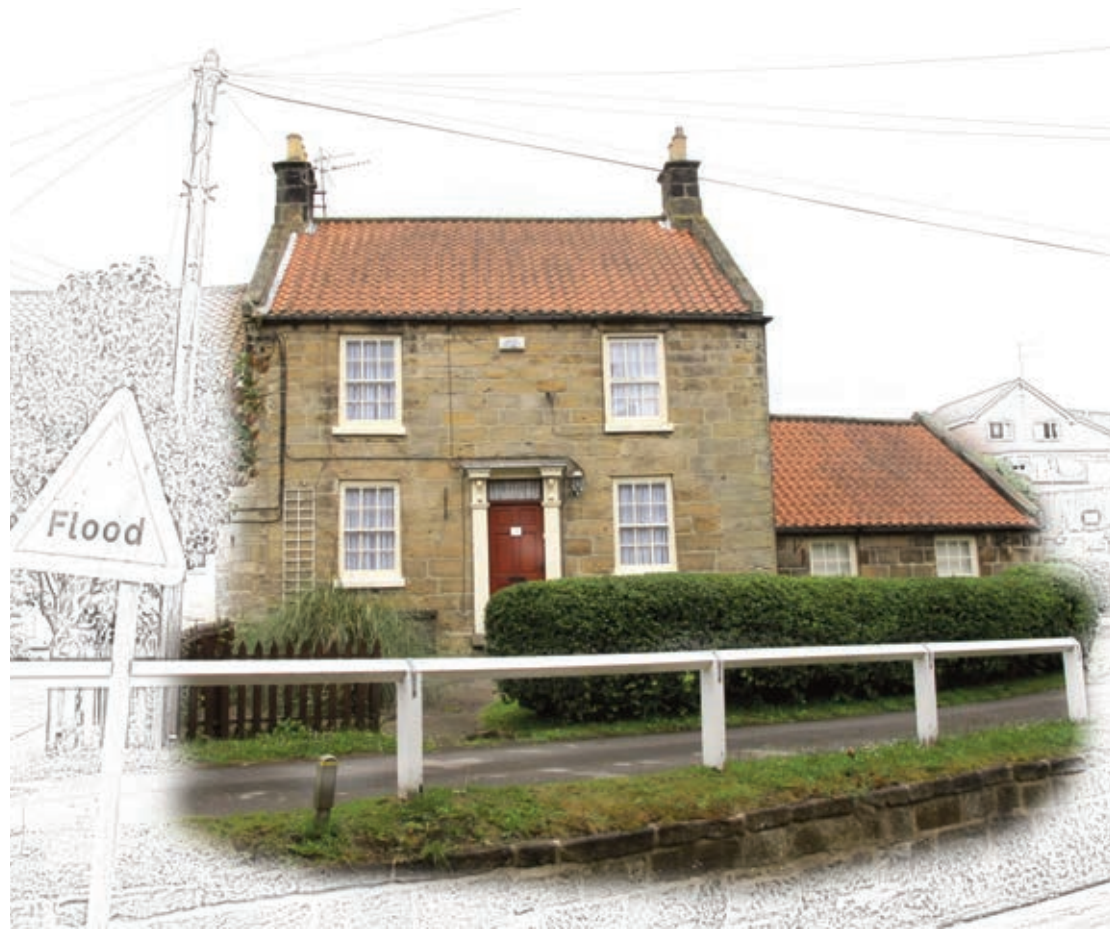
Locally quarried sandstone blocks in hues of orange, brown, grey and yellow, now generally weathered to a mature patina, are typical facing materials. Sandstone was used for both high status buildings as well as humble cottages, with lesser buildings constructed using quarry rubble.

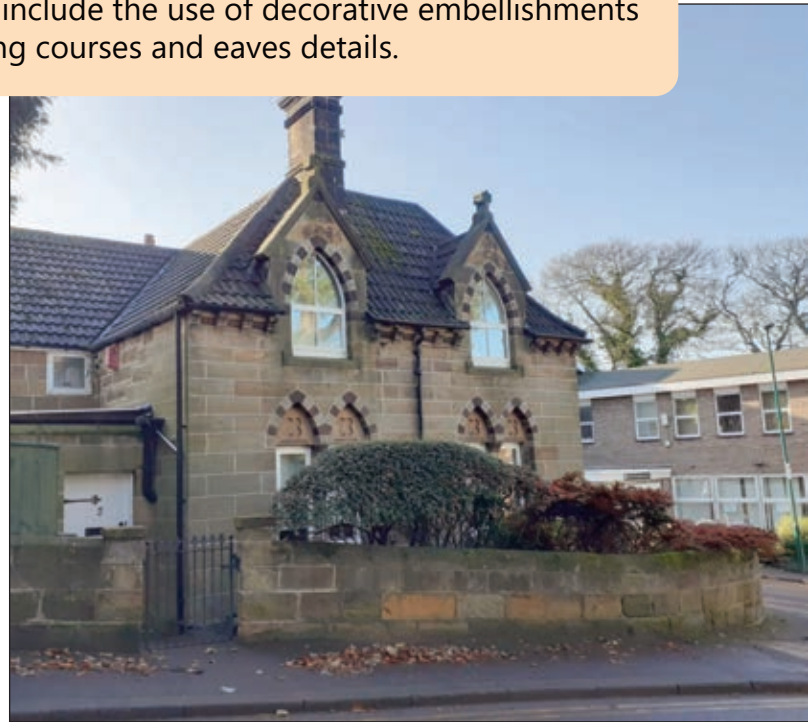
Windows are predominantly of 'portrait' format, including the generally flat topped single and 2-storey bay windows that may be canted or square/rectangular in plan, frequently with ornate cornices and wide mullions. Some vertical sliding sash windows are still present, with each individual sash containing one or two panes of glass.

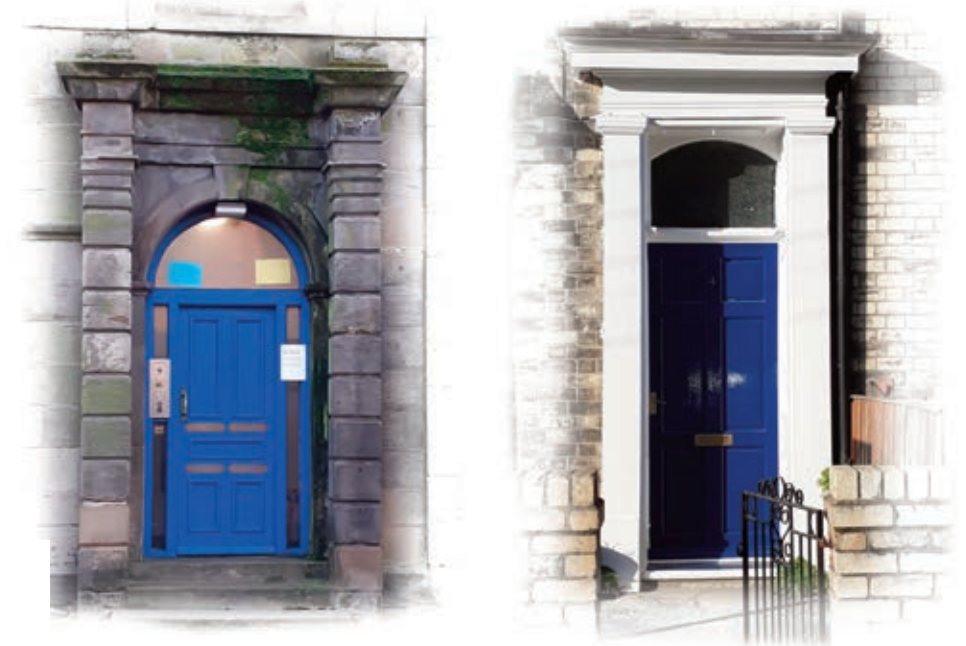
Doors in later buildings tend to be of four or more square or rectangular-shaped panels, sometimes with the upper panels glazed. Doorways may have ornate carved doorcases, usually in timber but occasionally stone in larger buildings.
