# this is Loftus Conservation Area Appraisal 2023

# 1. Introduction

## The Designation of Loftus Conservation Area

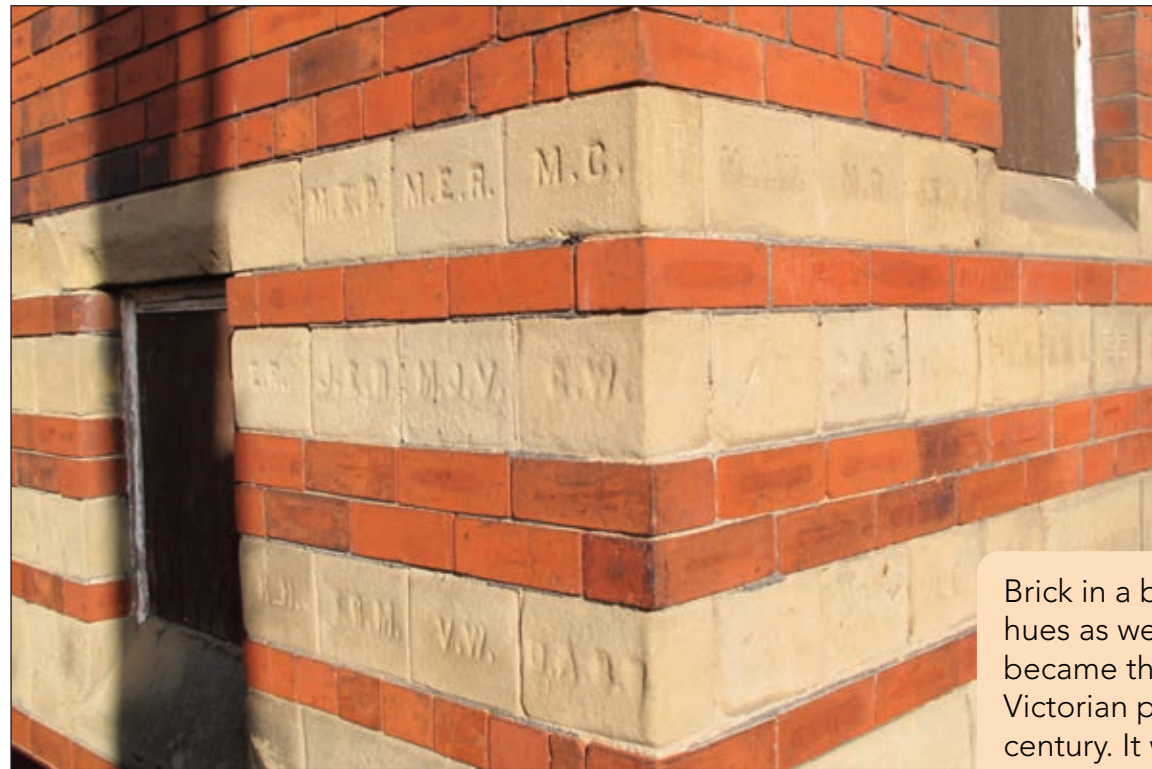
Brick in a broad range of red, orange and brown hues as well as creamy white 'Pease' bricks, became the staple building material in the Victorian period and throughout the 20th century. It was used in a variety of ways, creating bonding and multi-coloured patterns with moulded bricks and stonework used to create architectural details.

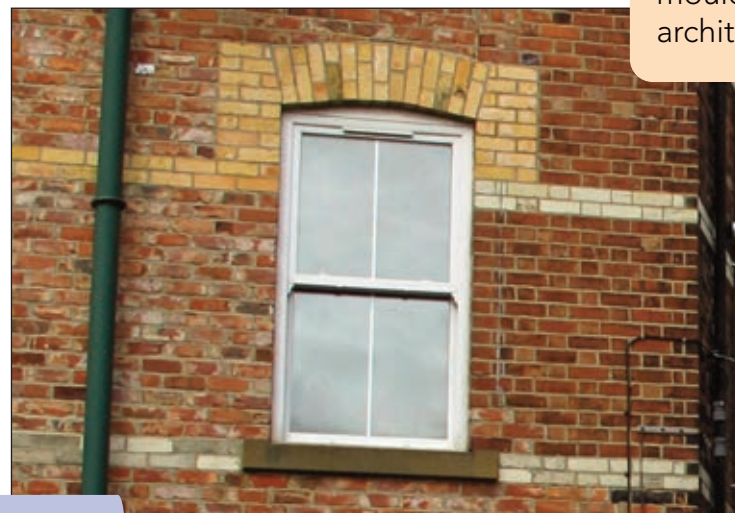
Finely fenestrated sliding sash windows have frequently been replaced with uPVC casements, which have overly bulky frames and lack the proportion of the originals. Bay windows have frequently been modified, with strong timber mullions replaced with insubstantial extruded polyvinyl strips, detracting from their appearance and the special character of the area.

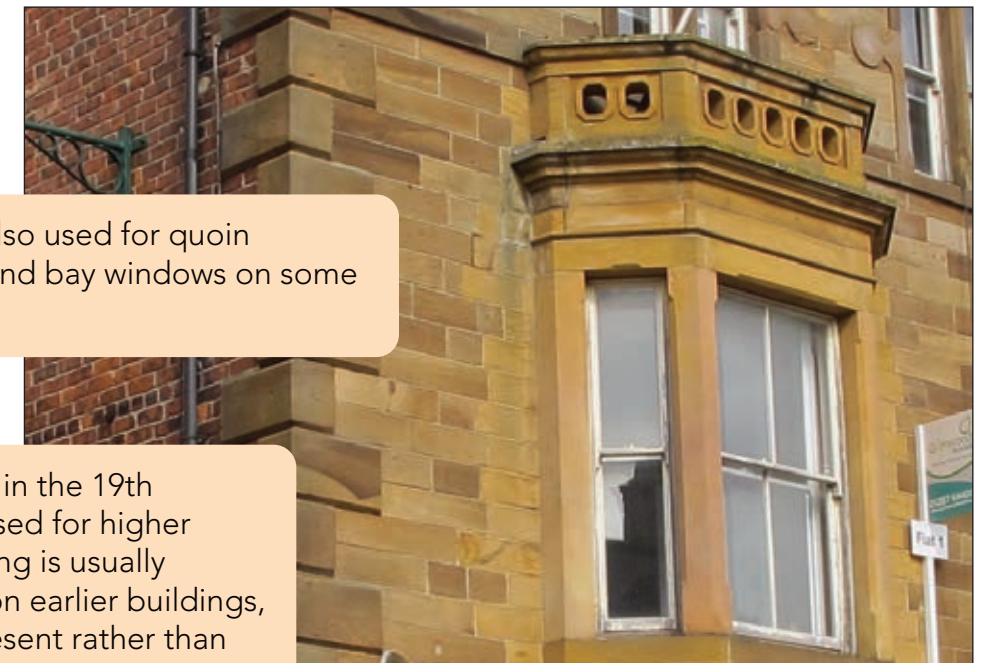
Despite the proliferation of brick in the 19th century, stone continued to be used for higher status buildings. However, dressing is usually different to the stonework seen on earlier buildings, with smooth faced fine ashlar present rather than traditional herringbone dressing.

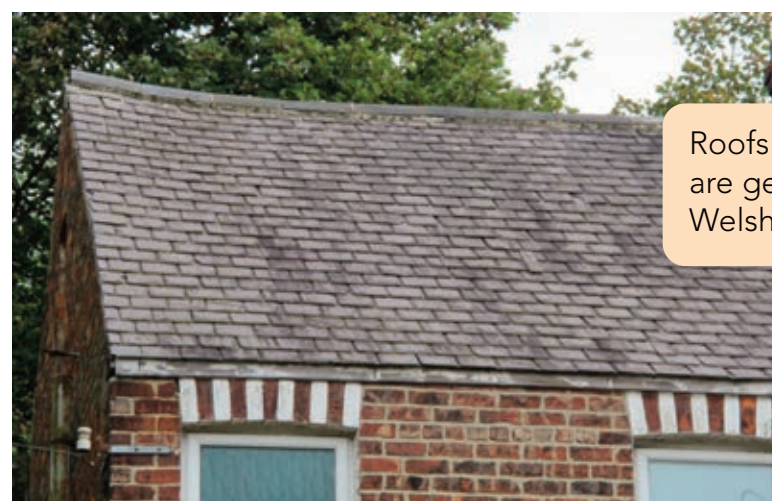
Roofs of Victorian and Edwardian buildings are generally covered with grey/blue/black Welsh or Cumberland slate.

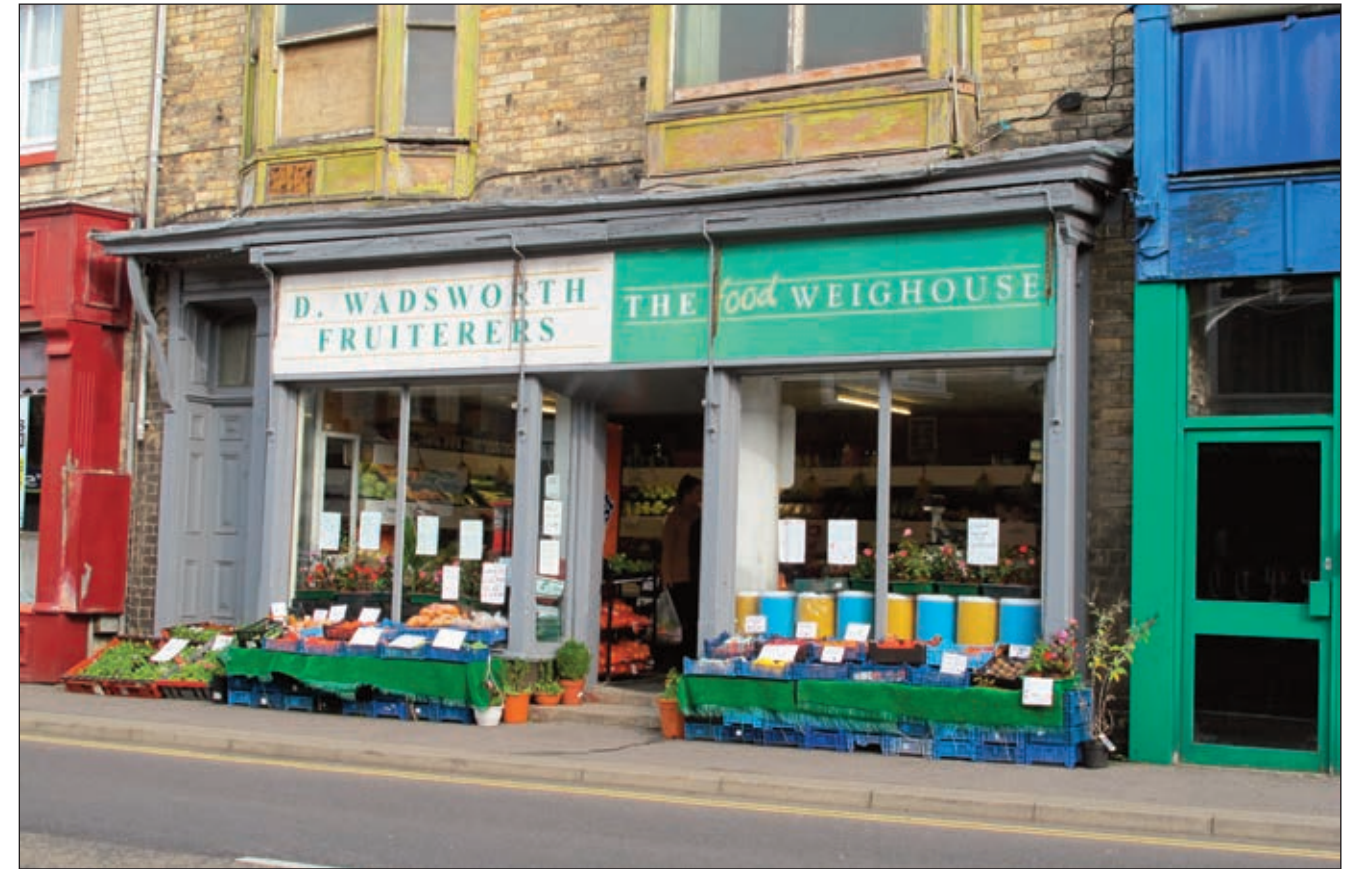
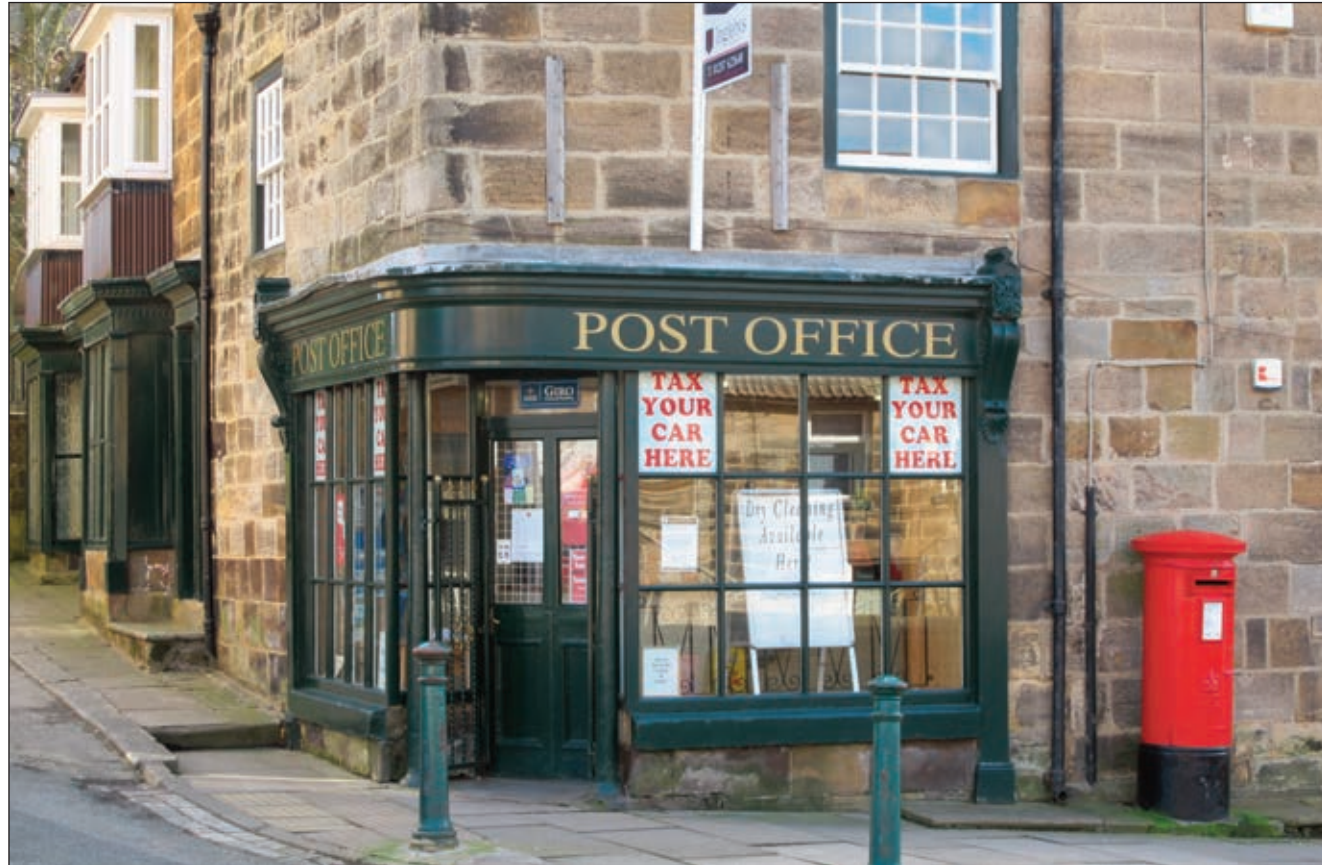
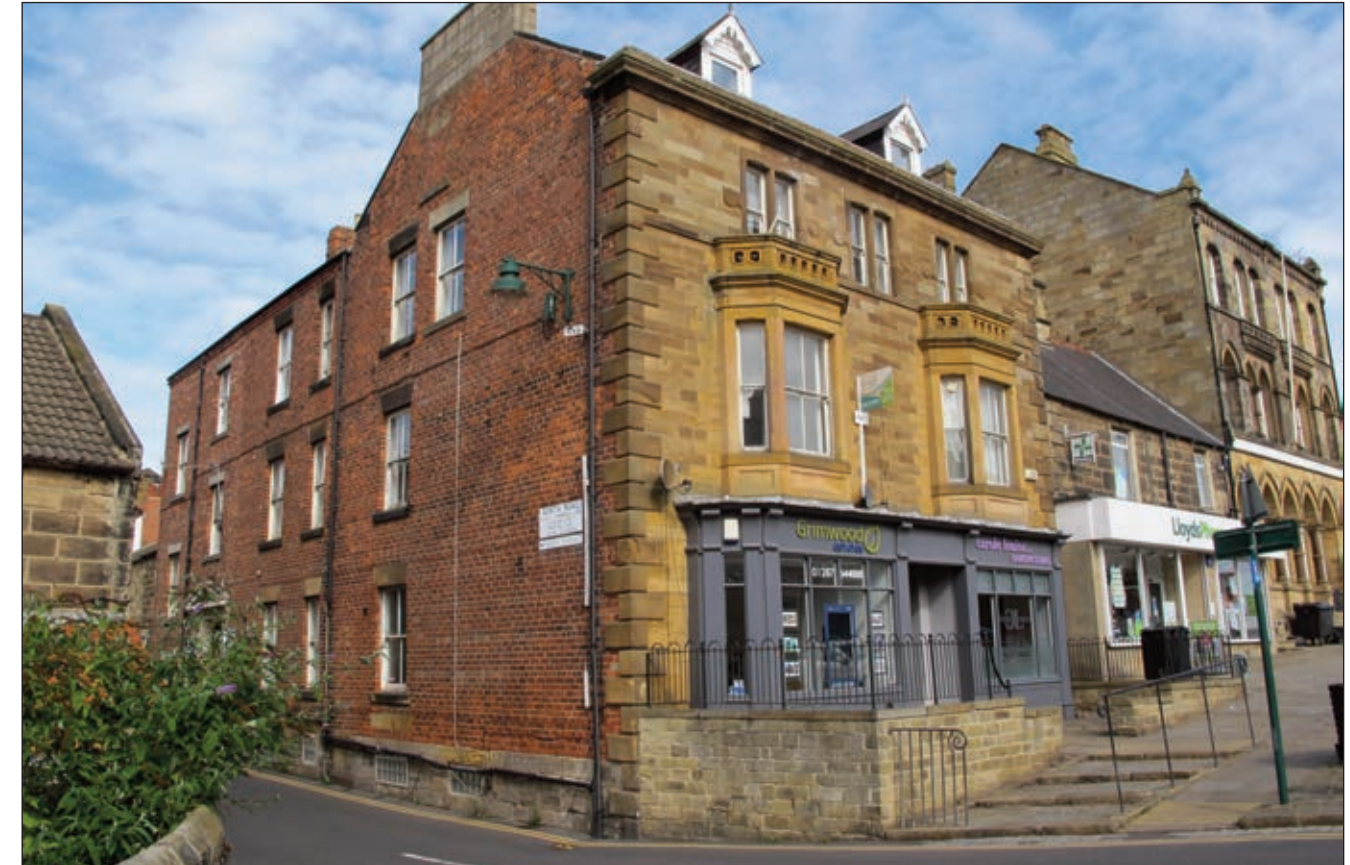
Historic shopfront detailing removed, or replaced with plain modern boards.

Inappropriate non-traditional advertising.

Roller shutters screening shopfronts.

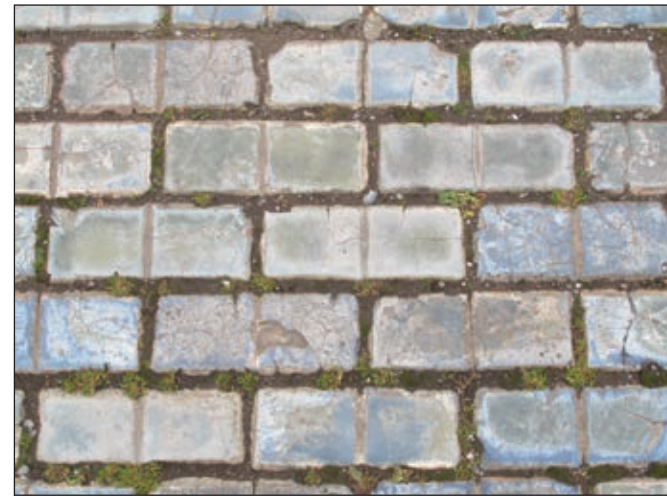
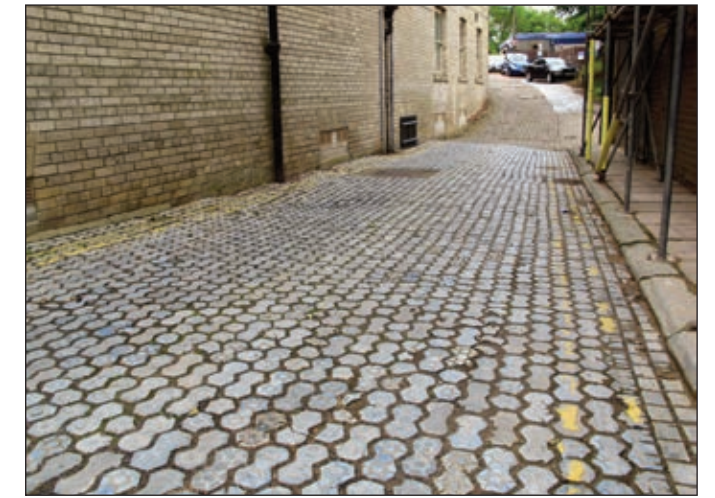
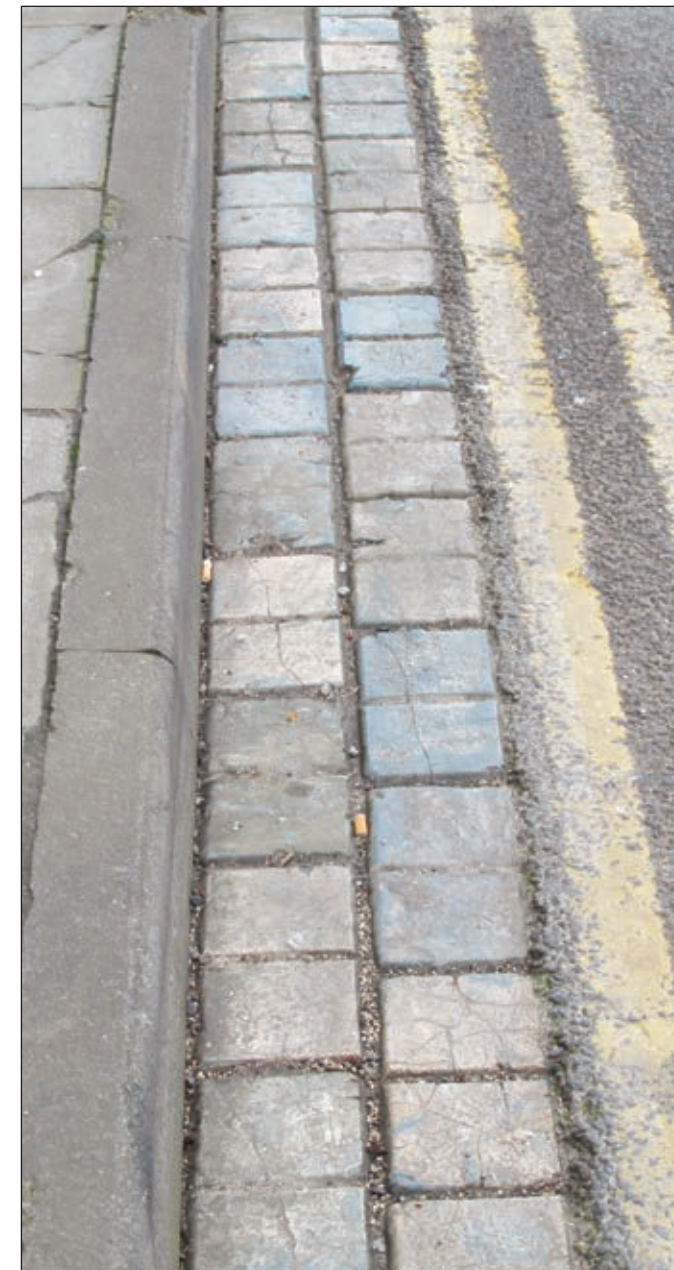
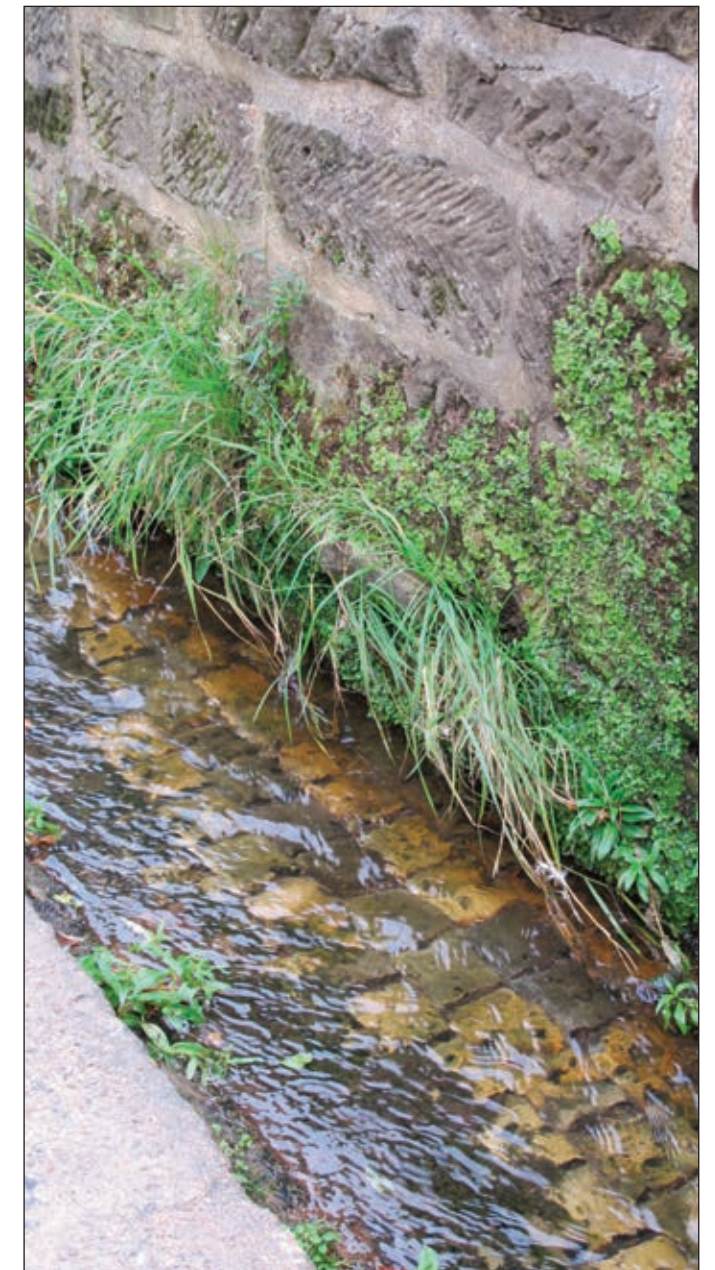
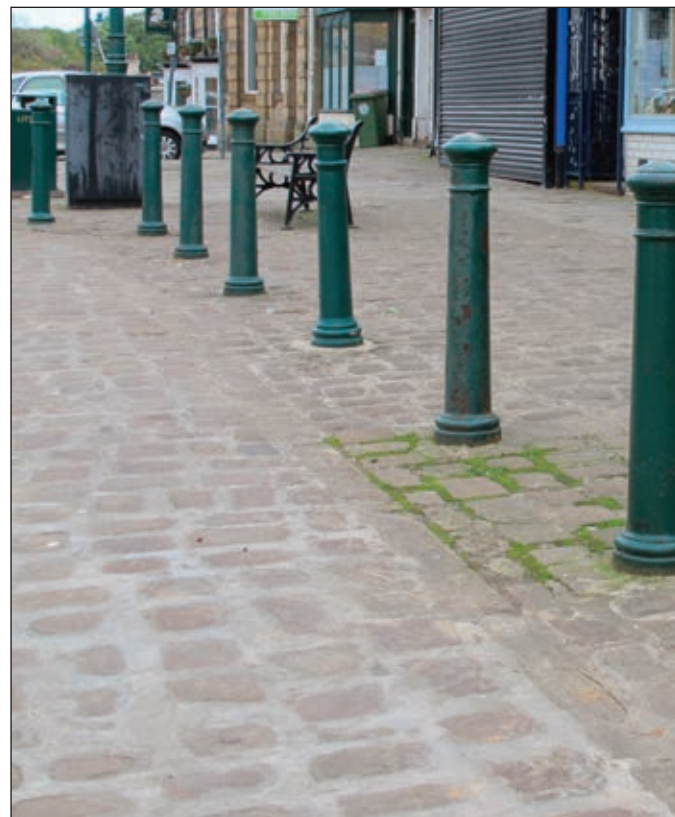
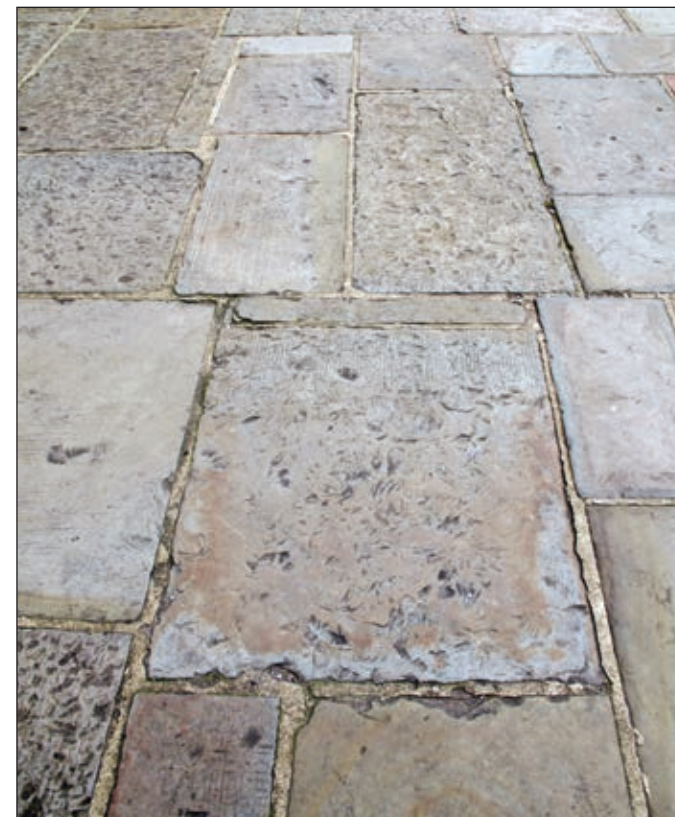
- 4.42 There are a few 'original' examples of attractive, traditional surfacing materials including whinstone, scoria and brick sets:
- Roadside drainage gulleys along the High Street.

- Several lanes and alleyways leading off the main road, e.g. the lane leading to Co-operative Terrace.
  - Many back lanes, private yards and drives.

- The stream channel in Dam Street.

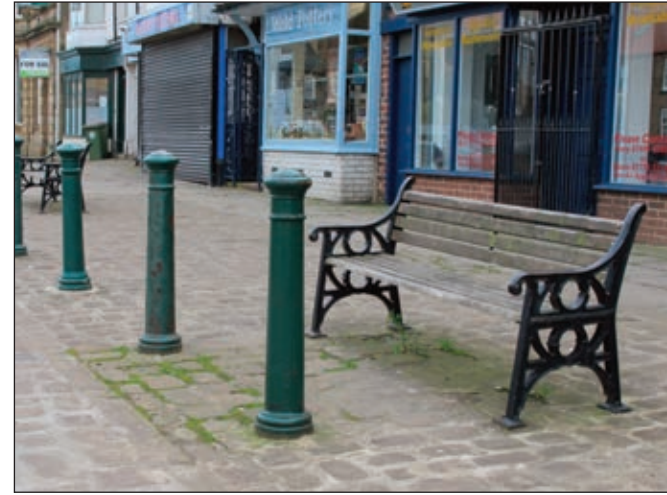
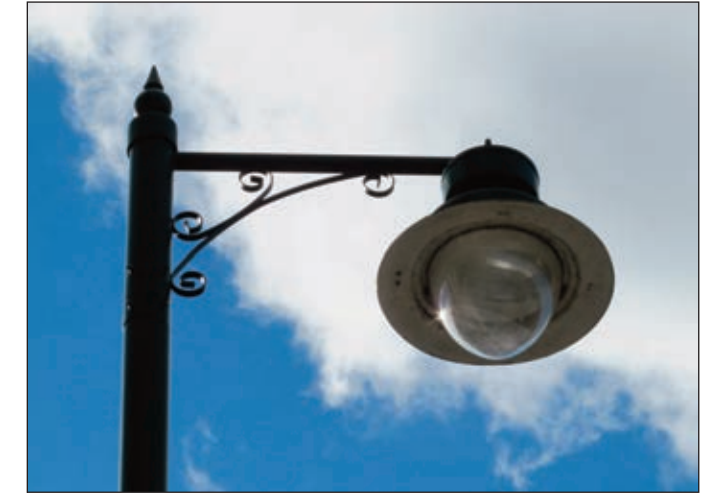
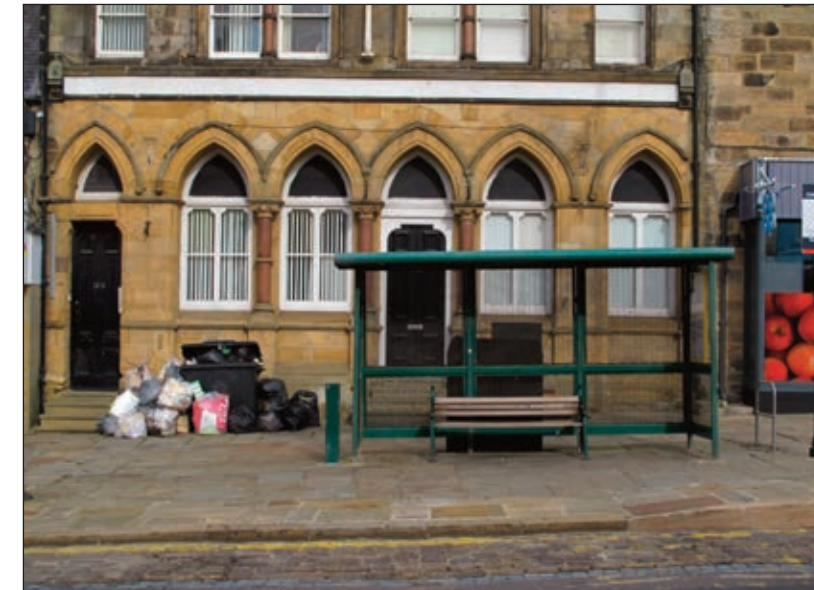
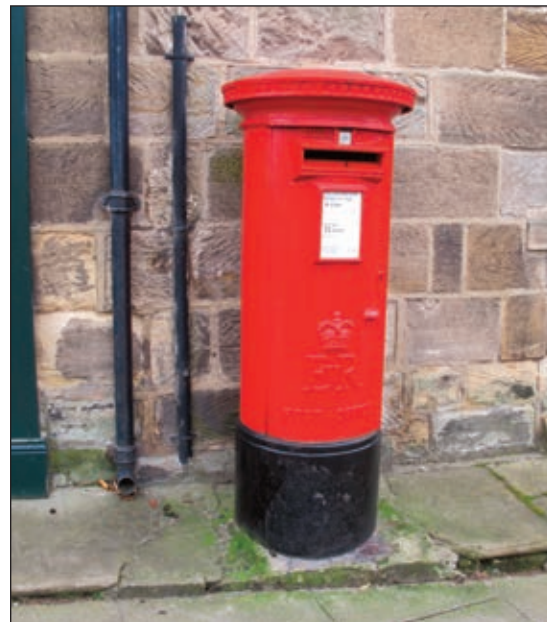
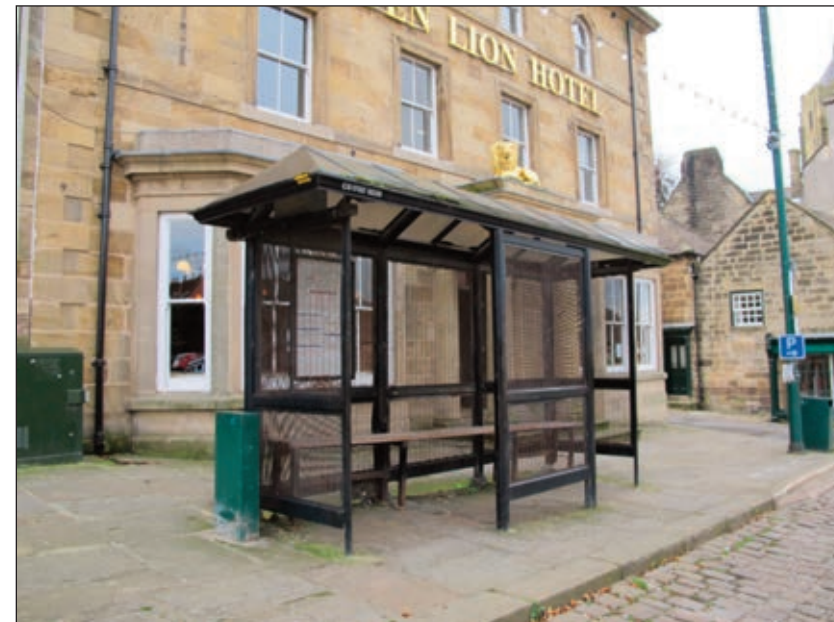
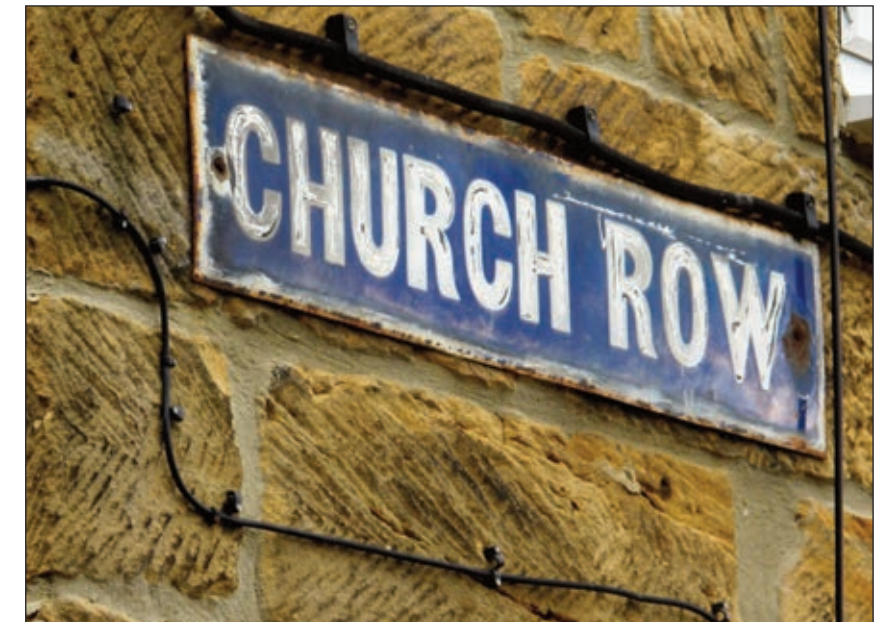
- 4.44 The existing, Victorian style, dark-green street lighting columns, lanterns and other street furniture on the High Street, including cast iron bollards and benches, were installed by the 1990's scheme referred to earlier. This has set a standard to be aimed for elsewhere throughout the conservation area where street furniture and traffic signs, including markings on the carriageways, are generally lacking in design and aesthetic appeal and consequently detract from the area's special character.

- 4.45 Elsewhere on the High Street some street furniture is awkwardly placed. Bus shelters partially obscure the front elevation of the GII listed Golden Lion and GII listed former bank premises on the opposite side of the Market Place, detracting from their architectural merit.

- 4.46 On occasion mobile refuse containers have been left on the pavement on a permanent basis, ostensibly from reluctance to use integral bin stores on buildings converted to residential accommodation. The problem is especially noticeable on collection day when refuse bags are commonly also piled up.

- 4.47 Some examples of historic signage can still be found on nearby side streets, which appear in need of maintenance if they are to be preserved. Historic pillar boxes also add to character and provide colourful punctuation to the street scene.

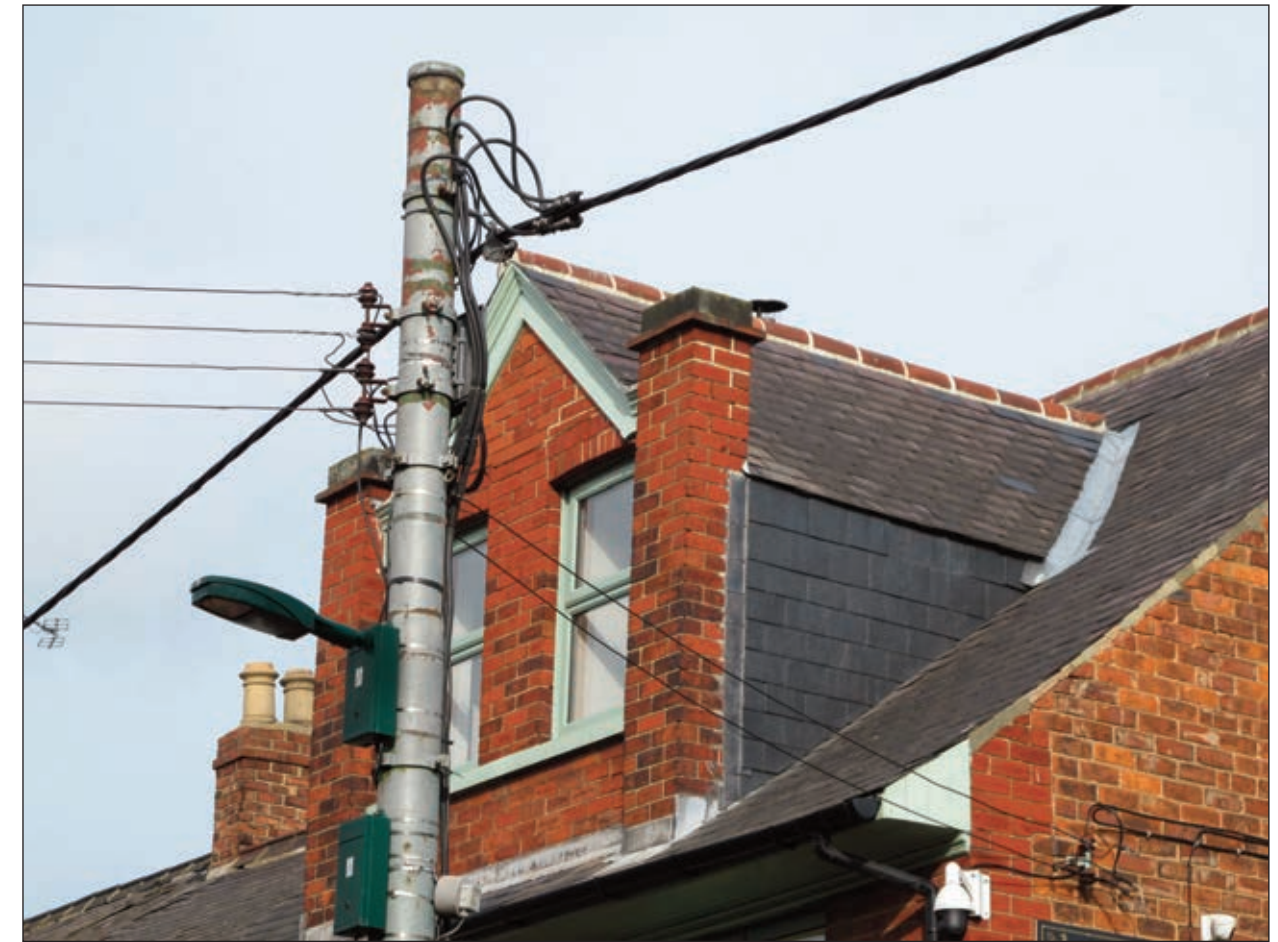
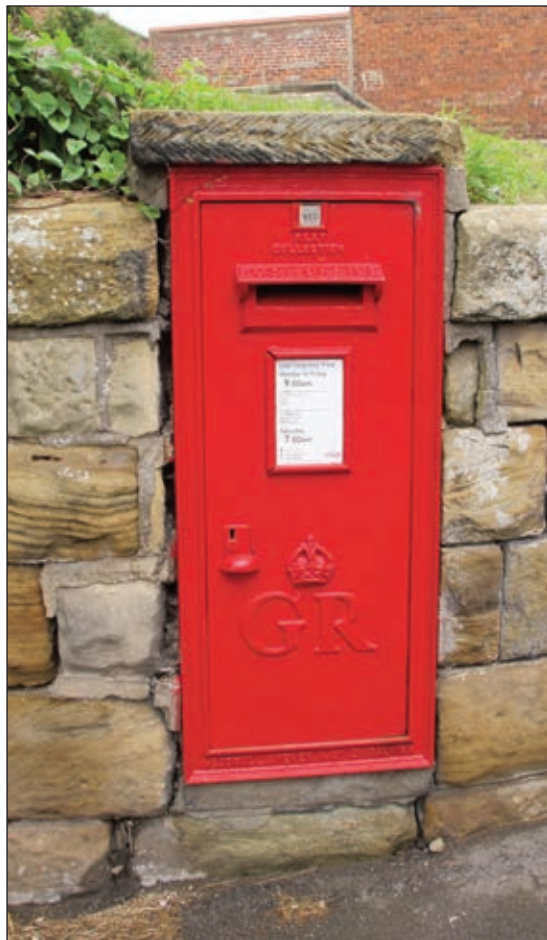
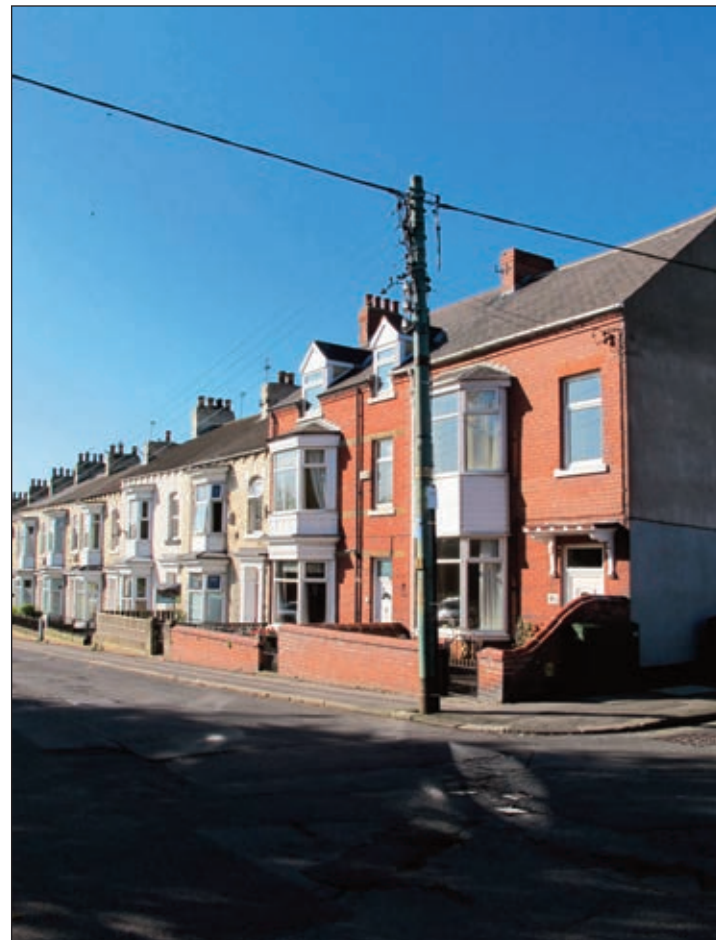
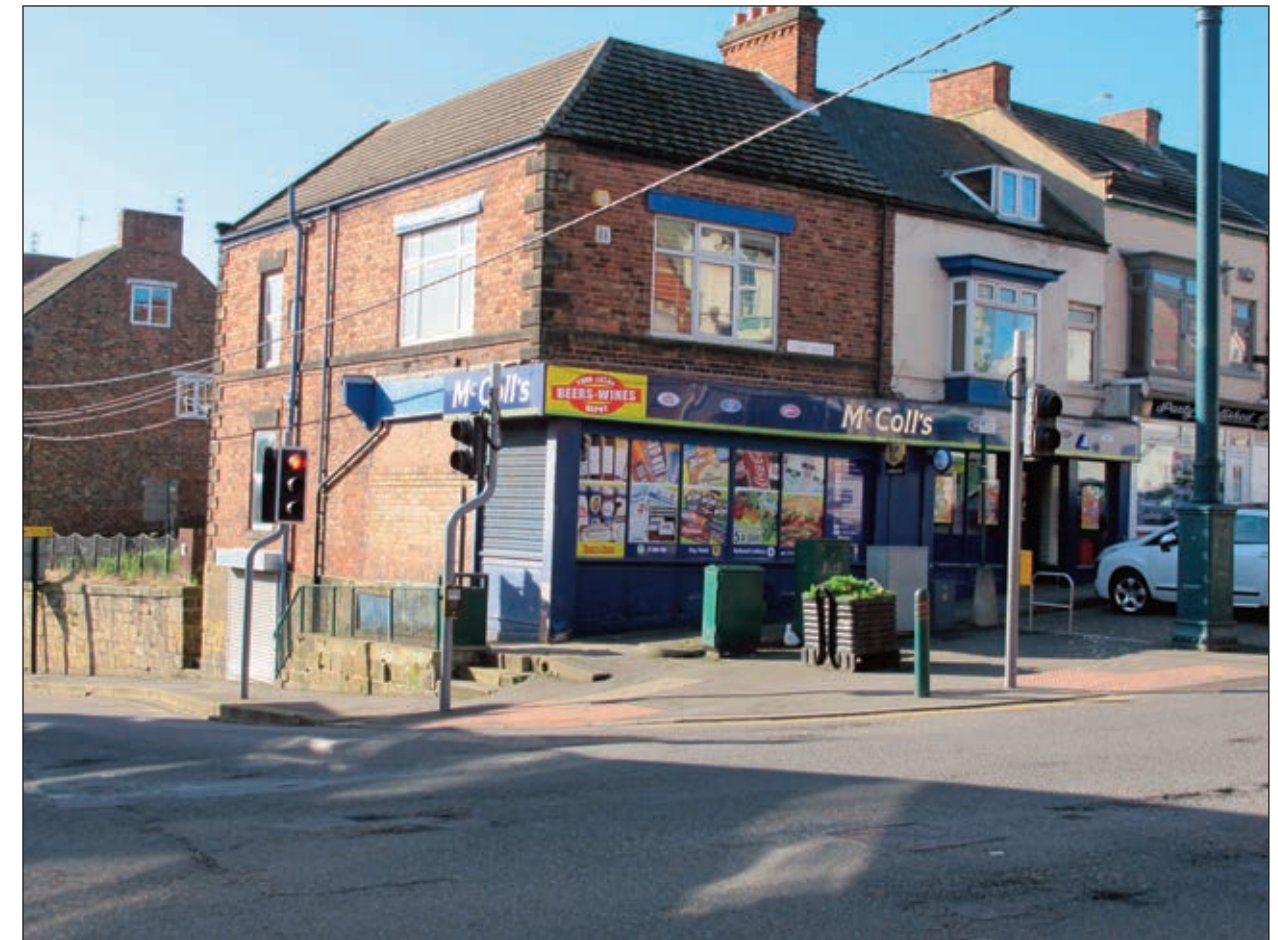
- 4.48 The apparatus of statutory undertakers' pole-mounted service wires and steel distribution cabinets are visually intrusive and lend a temporary feel to the infrastructure. Electricity arrived in Loftus in 1906 and whilst the current poles and cables are from a much later date, it is anticipated that they will be removed and the cables buried in the future.

- 4.50 Other street furniture such as bollards and litter bins are modern utilitarian types, which appear to have been chosen without consideration of the conservation area designation. Characterful street furniture items found around the market place but missing from the Zetland Road area are benches and bollards, ostensibly due to the restricted narrow pavements. A traditional post box recessed into a stone wall does however provide some historic colour.

- 4.51 Characterful street furniture items found around the market place but missing from the Zetland Road area are benches and bollards, ostensibly due to the restricted narrow pavements. A traditional post box recessed into a stone wall does however provide some historic colour.
