CONTENTS

1. INTRODUCTION

- 1.1 This document is an appraisal of Home Farm and Hutton Hall Area and is based on a detailed analysis of the character of the area. The document is broken down into two parts. Part one examines the aspects that form the natural and built environment of Home Farm and Hutton Hall area. Part two of the document provides the justification for the creation of a new Conservation Area and proposes a potential Conservation Area boundary.

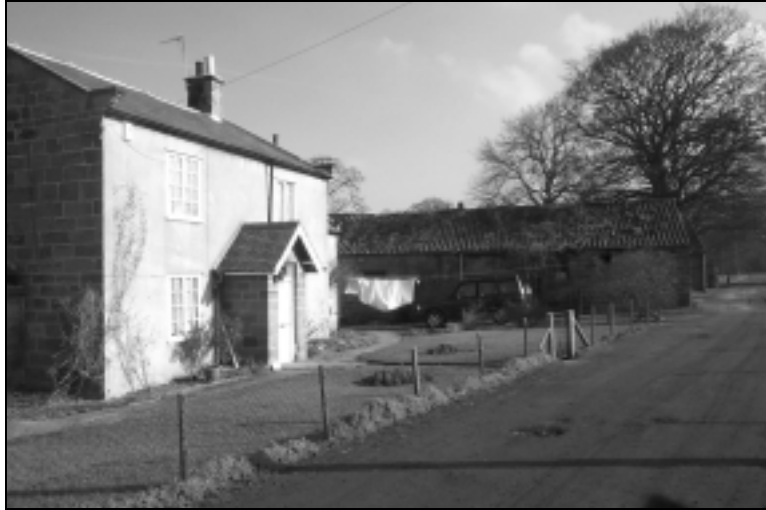
Photograph 1

- 4.2 The Home Farm Farmhouse was built in the early 19th century of dressed sandstone that is now rendered on its front elevation. It is a two-storey building with two bays. It has a slate roof with stone ridge and gable copings and kneelers with stacks at the gables. There is a central mid 19th century gabled porch built of dressed sandstone with a slate roof and bargeboards. This farmhouse is shown in photograph 1.

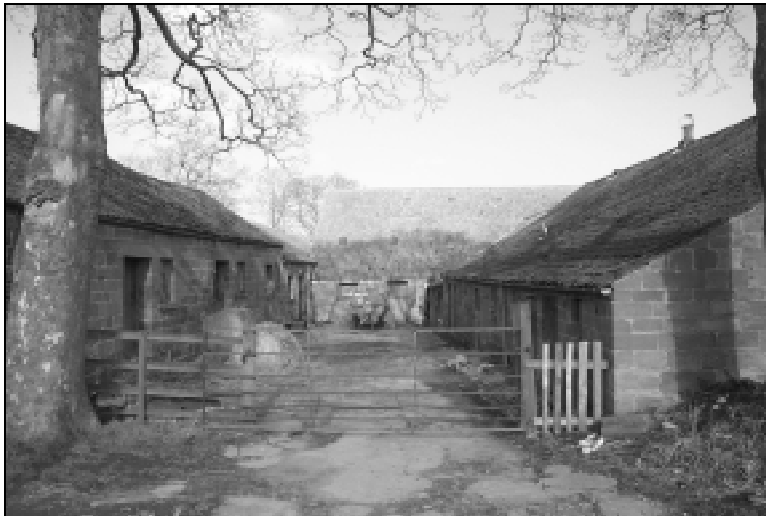
- 4.3 The Cart Shed, Granary Barn and Loose Boxes to the east of the farmhouse are built to an 'E' plan. Photograph 2 shows part of this 'E' shape. The Cart Shed is dated 1826 on the keystone on the centre arch. The buildings are built of dressed sandstone and are clay pantile hipped with gabled roofs with stone ridge copings. In the west wall of the stable building adjacent to the farmhouse are three sculpted stones from a medieval building dating from the 12th century. It is thought that these stones date from the hospital of St Leonard. One stone is the head of an ogee arch.

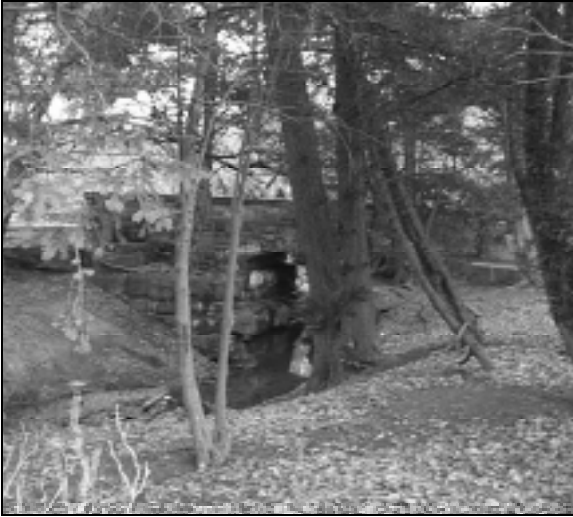
Photograph 3

- 4.6 This bridge is grade two listed and is located 250 metres to the north west of Hutton Hall. This bridge provides the first access over the Hutton Beck whilst travelling up Hutton Lane to Hutton Hall. The Lodge is also accessed from Hutton Lane. The bridge was built in 1866 and is thought to have been designed by Alfred Waterhouse as part of the surrounding landscape of Hutton Hall. This bridge is shown in photograph 3.

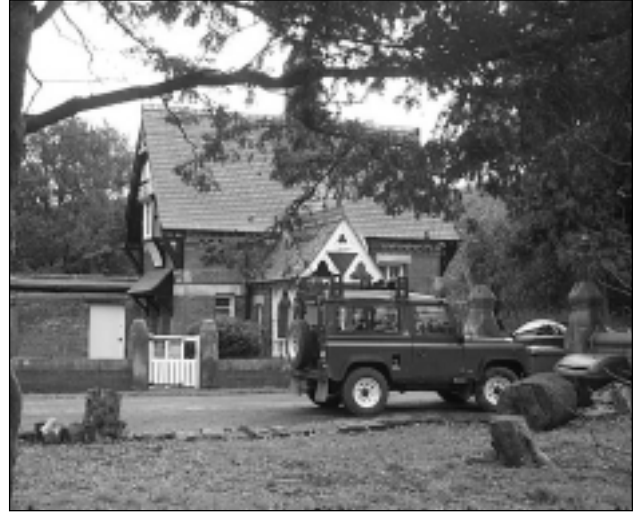
Photograph 4

- 4.7 The Lodge is a grade two listed building located 220 metres to the north west of Hutton Hall. This is thought to have also been designed by the architect Alfred Waterhouse and forms part of the original Hutton Hall Estate. The lodge is presently an occupied dwelling. The Lodge is built of matching materials and style to Hutton Hall and has a gabled roof with bracketed verges. It is one and a half storeys high. The boundary walls, gate and gate piers to the Lodge and the Lodge's drive are also listed. The Lodge is shown in photograph 4.

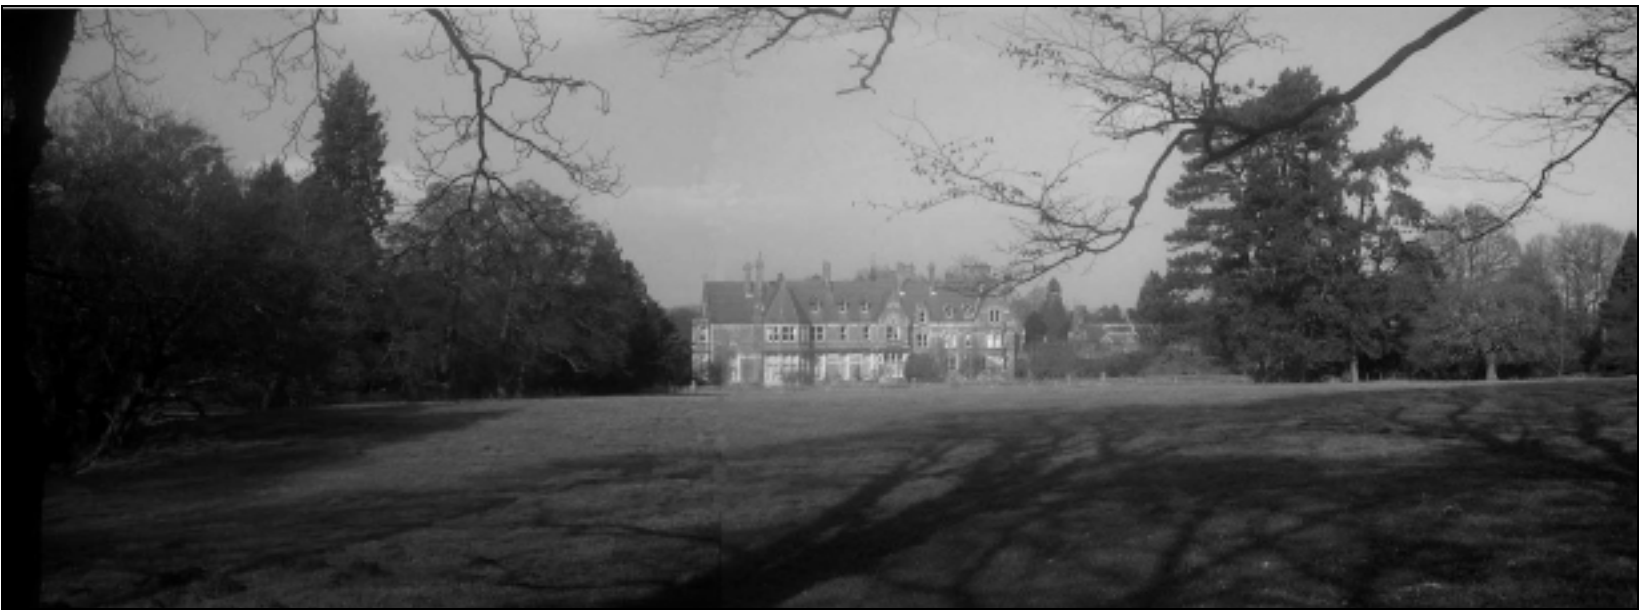
- 4.9 Hutton Hall is a large country mansion in a landscaped park. It is a two storey Victorian gothic dwelling. Photograph 5 shows the southern elevation. The building is designed with balanced asymmetry in seven bays. 1866 is written on the tablet above the main entrance porch. Hutton Hall is built in red brick with stone dressings with steeply pitched hipped and gabled Welsh slate roofs with bands of 'fish scales'. There are ornamental cast iron ridge crestings. Hutton Hall has stained and painted glass in its west and north elevations. Adjoining the east side of Hutton Hall is a large dilapidated, split level conservatory. This is brick with stone dressings and it has a glazed roof, which has largely collapsed. During the Spanish Civil war Hutton Hall was used to house refugees who burnt a number of the floorboards while staying warm.

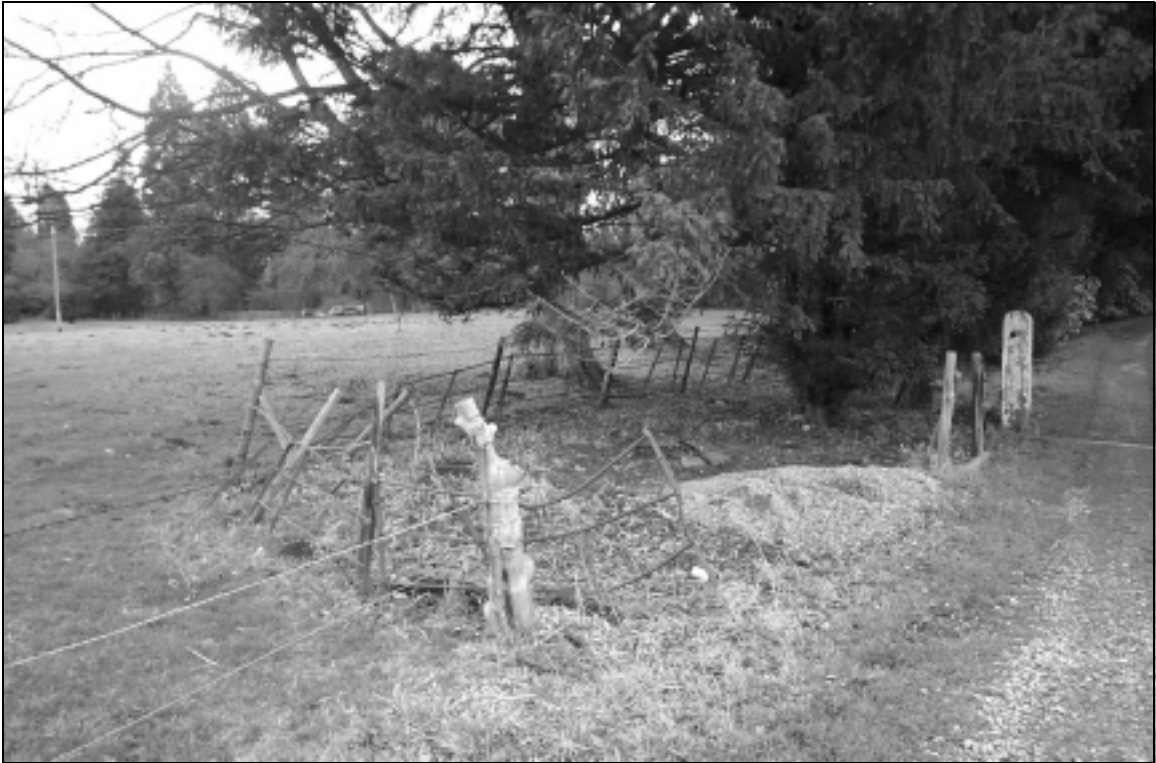
Photograph 12: Traditional Fencing

- 5.1 The majority of the local details and features of the area have a strong industrial association with the Hutton Hall Estate and with the Pease family. As such they are important elements that contribute towards the distinctiveness of the Hutton Hall and Home Farm appraisal area.
- 5.2 One of the distinctive features is the traditional fencing that still exists in many parts of the area and especially on the main lanes. Examples of this fencing are shown in photographs 12, 13 and 14. Photograph 12 shows an example of the traditional fencing that is in very poor condition. Photograph 13 shows an example that has been painted white unlike the original that was dark in colour.

- 5.3 This type of boundary treatment is visually ‘open’ and allows views through and across the appraisal area. This makes boundaries less definitive and softer. Using boundary treatments like this allows different areas to merge together and they are also representative of the details of the period of original construction.

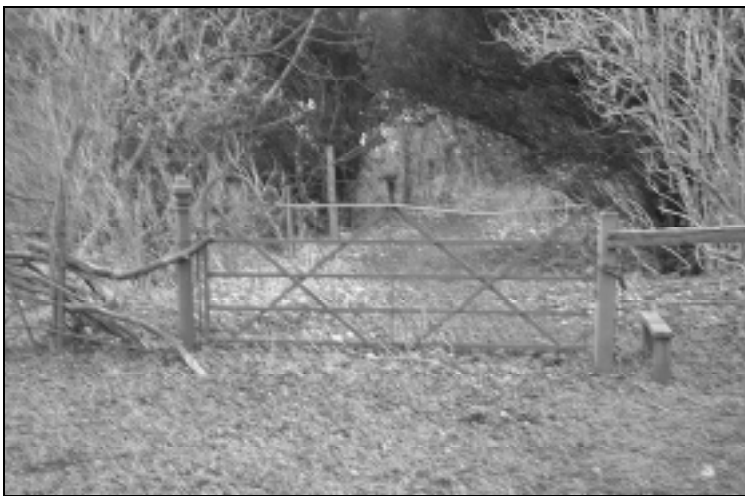
- 5.4 In the site of the old parkland there are a number of original features that exist. Examples of this include several gates that date back to the 1860's. Photograph 15 shows an example of an original gate and photograph 16 shows an example of an original style latch on a gate.

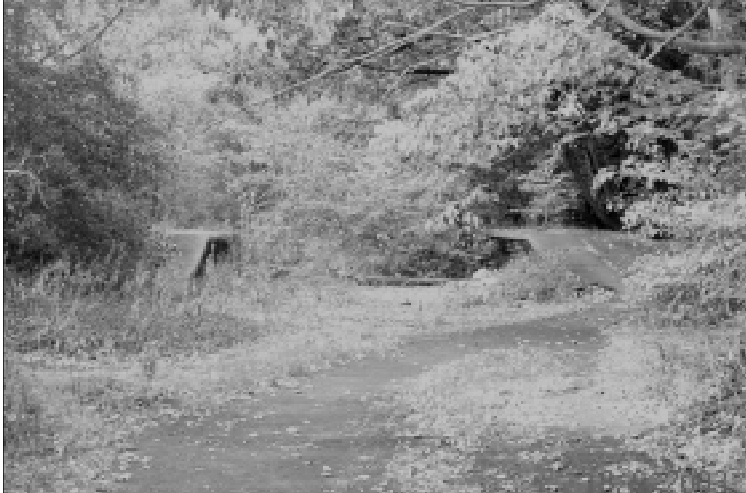
Photograph 17

- 5.5 The station platform from Hutton Gate Station still exists and now forms part of a right of way that runs along the southern edge of the area. This platform is now very overgrown and is shown in photograph 17.

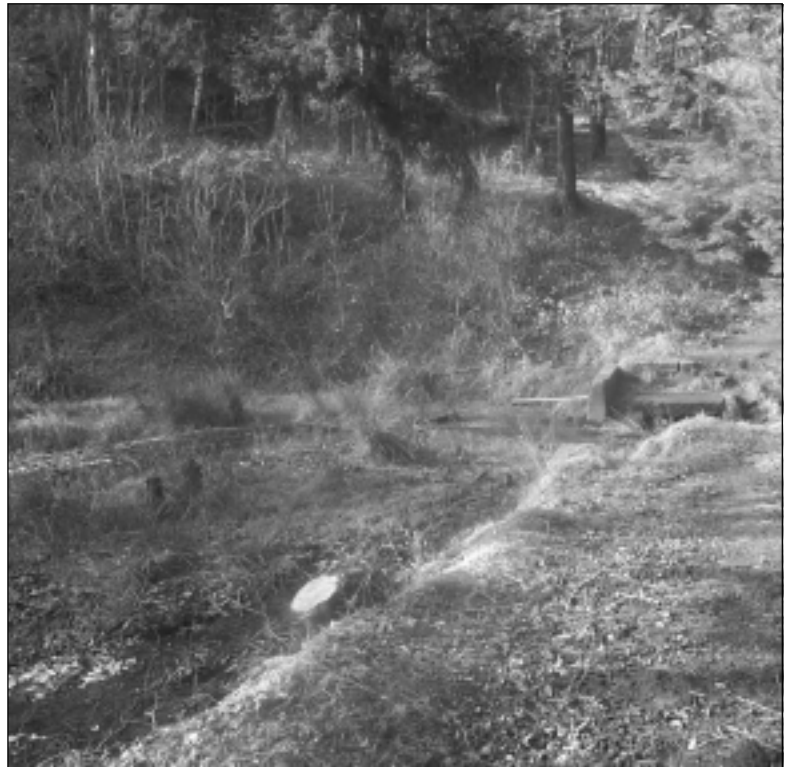
- 5.8 Photograph 21 shows Blue Lake. Blue Lake is situated approximately 400m from Hutton Lane in Blue Lake Woods. Blue Lake was purposefully constructed to provide the power to run the hydraulic hoist and other machinery at Home Farm. Blue Lake is currently marsh ground. There is an interpretation board at Blue Lake that provides information on the history of it and ecology of the lake. The Friends of Home Farm are seeking to reinstate Blue Lake to its former condition.

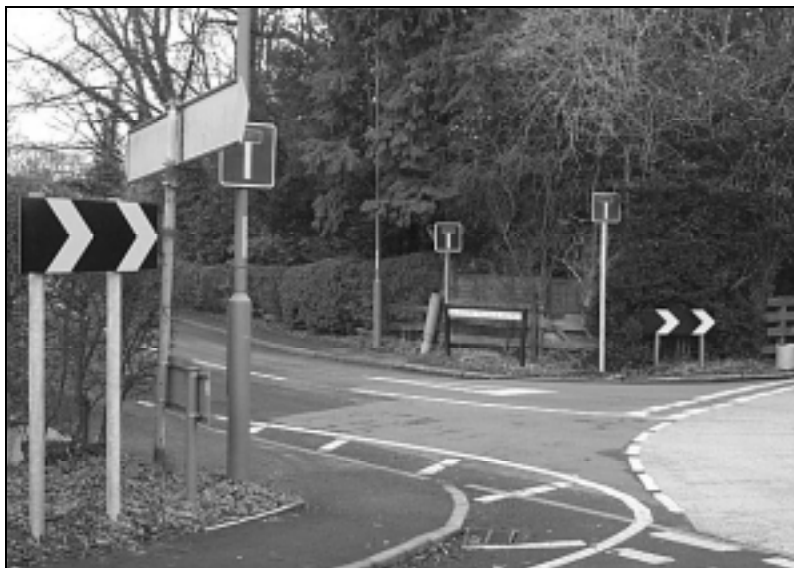
- 8.3 There are a number of areas around the appraisal area that are affected by clutter of excessive numbers of signs. Photograph 27 shows an example that was taken at the entrance of Hutton Lane where there are three signs serving the same purposes. Photograph 28 shows an example where there are unused signposts around the appraisal area. When new essential signs are put up then the redundant signs and posts should be taken down. If it is possible then the signs that have to be on posts should be more muted, for example painted black or green rather than white or grey, so that they are less dominant. If it is possible the signs should also be fixed on shorter poles.

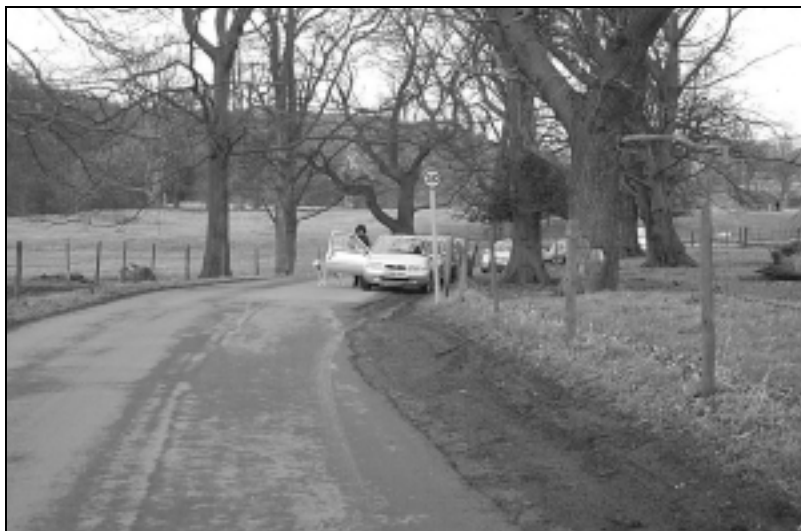
Photograph 29

- 8.4 The informal parking on Hutton Lane is causing damage to the roadside verges. This can be a real problem at weekends and on bank holidays when a large number of people drive here to use the area for recreation. An example of this erosion is shown in photograph 29. However the alternatives of providing more formal parking maybe much worse than the erosion of the verges. If a proper lay-by were built then it would give Hutton Lane a suburban feel, which would detract immensely from the character of the area. To address this problem successfully people should be encouraged to arrive here by different means, either by bus, cycle or by walking from the visitor car park at Pinchinthorpe visitors centre.
