VERIFICATION REQUIREMENTS FOR GAS PROTECTION SYSTEMS

Technical Guidance for
Developers,
Landowners and
Consultants

Yorkshire and Lincolnshire
Pollution Advisory Group

Version 1.1 – December 2016

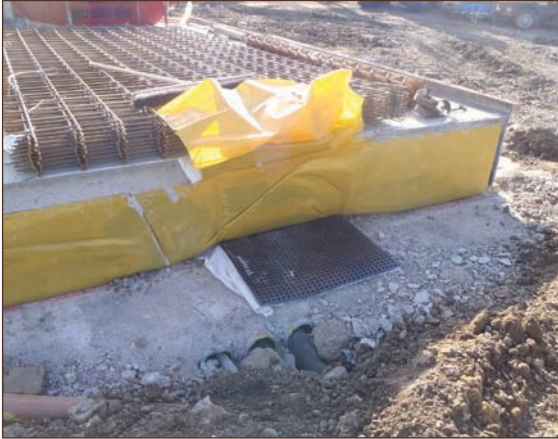
Figure A4.7 Geovent protruding out of the frontage of the unit. Gas membrane along the sides of the slab preventing lateral gas ingress (courtesy Alderburgh Group)

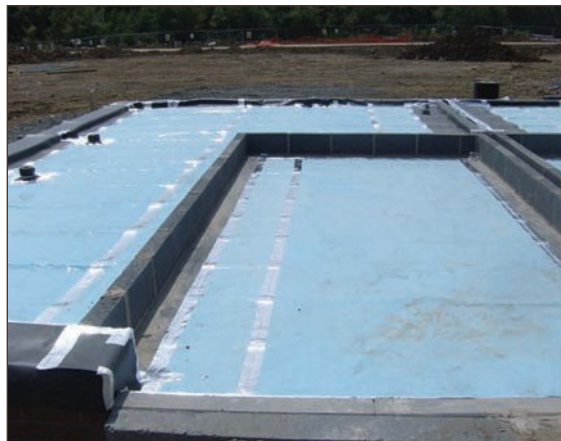
Figure A4.10 Almost complete coverage available for inspection, minimal jointing, service entries suitable distance from walls, light traffic (courtesy Smith Grant)

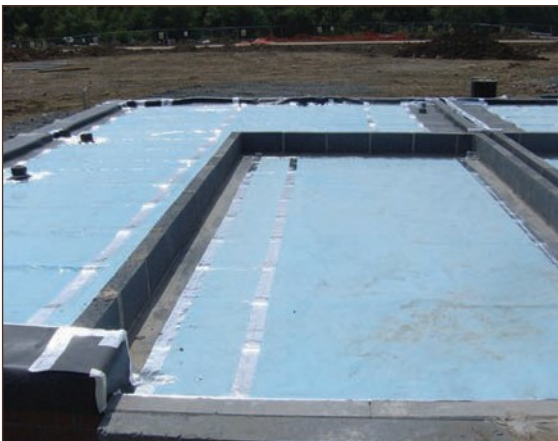
Figure A4.11 Gas membrane continued through cavity wall and above air bricks (courtesy Hydrock)

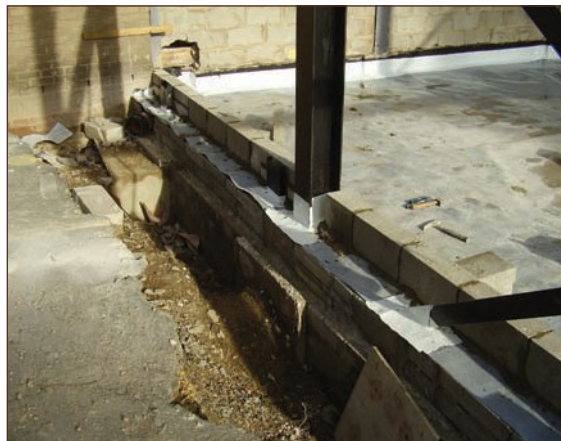
Figure A4.12 Good edge detail across cavity (courtesy PAGEotechnical Ltd)

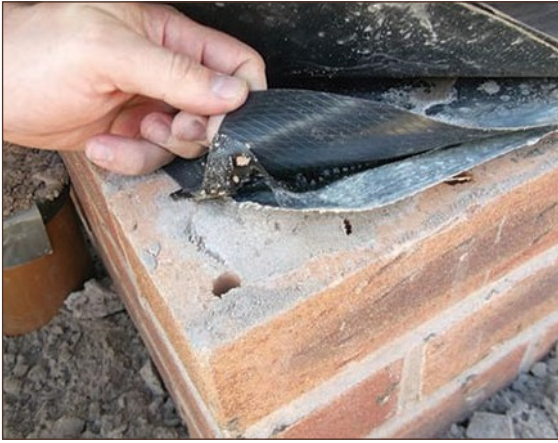
Figure A4.13 Gas proof DPC adhered on top of gas membrane using butyl strips across cavity space (courtesy NHBC)

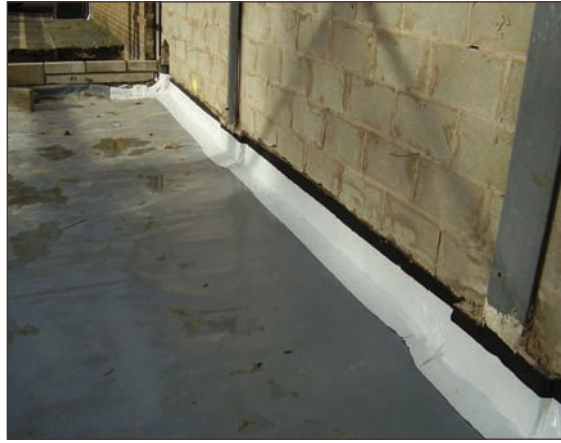
Figure A4.14 Good perimeter seal (courtesy PAGEotechnical Ltd)

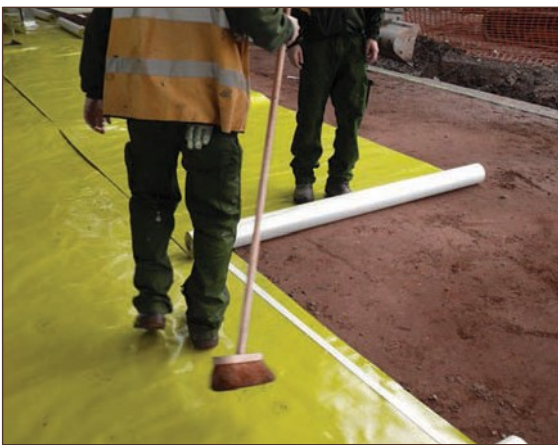
Figure A4.15 LDPE type gas membrane overlap and double sided tape. Sand blinding to protect underside of gas membrane (courtesy A Proctor Group)

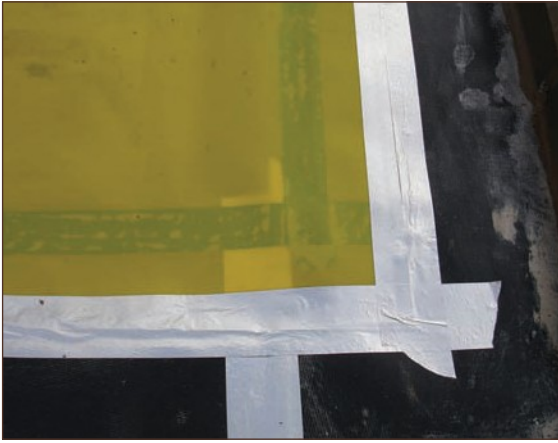
Figure A4.19 Well-constructed joints with gas resistant DPC, lap and double sided butyl joints visible beneath semi-transparent gas membrane, secondary seal with proprietary single sided tape (courtesy Smith Grant)

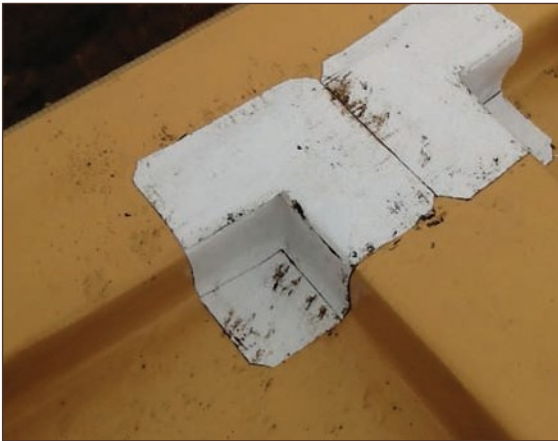
Figure A4.21 Good prefabricated corner detail (courtesy MEC Environmental Ltd)

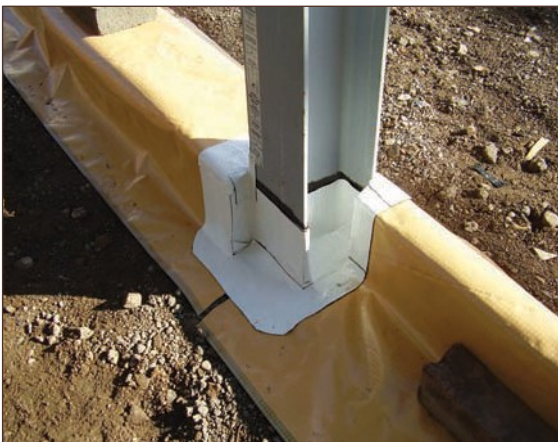
Figure A4.23 Complex column seal (courtesy PAGEotechnical Ltd)

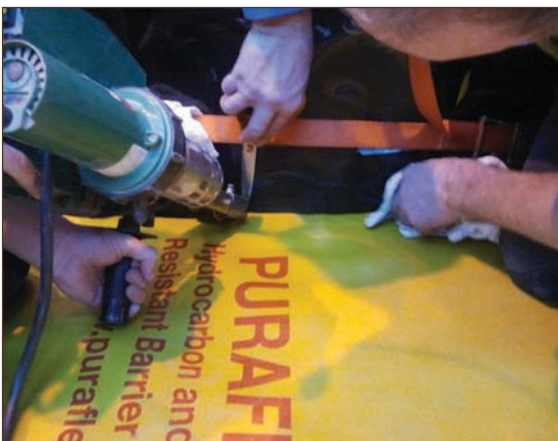
Figure A4.29 Extrusion welding technique (courtesy Industrial Textiles & Plastics Ltd)

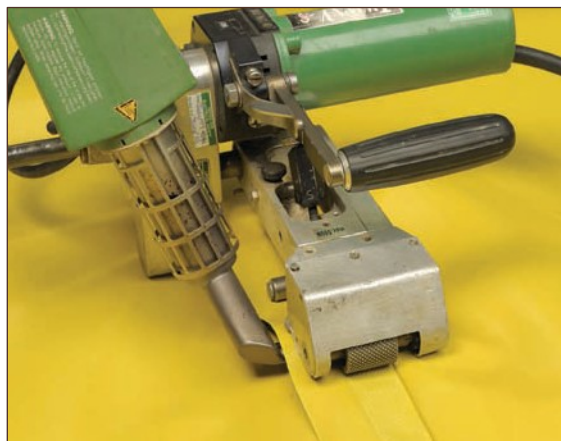
Figure A4.30 Thermal welding technique (courtesy Industrial Textiles & Plastics Ltd)

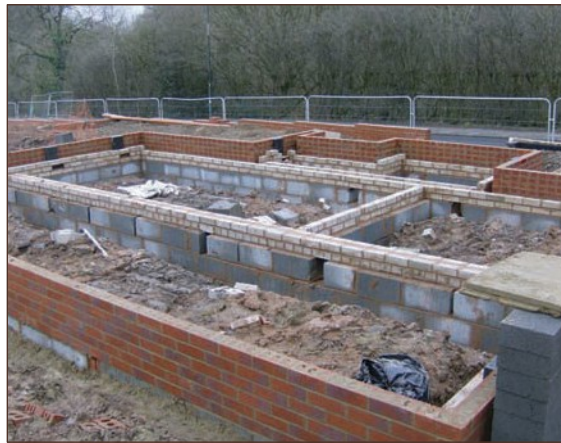
Figure A4.34 *Open void >300mm deep, good ventilation through internal sleeper walls (courtesy Smith Grant)*

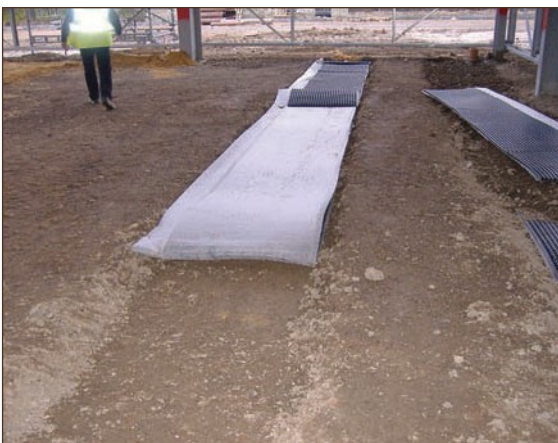
Figure A4.35 *Good installation of passive gas venting trenches and 'egg-crate' (courtesy Card Geotechnics Limited)*

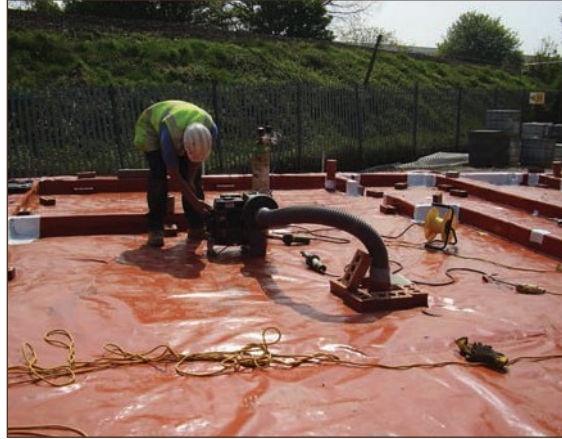
Figure A4.38 Tracer gas testing (courtesy PAGEotechnical Ltd)

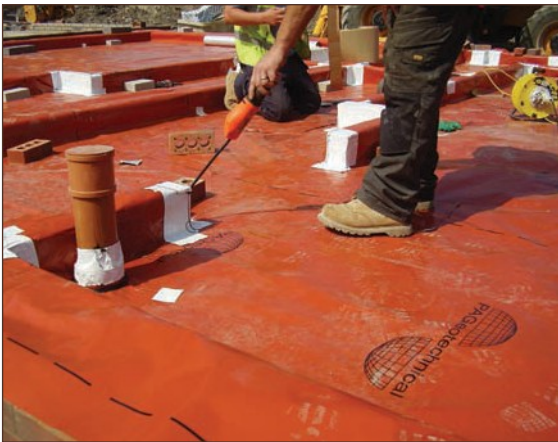
Figure A4.39 Scanning for leaks (courtesy PAGEotechnical Ltd)

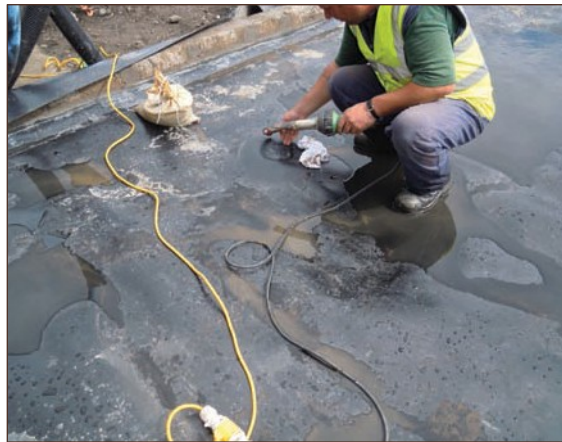
Figure A4.40 CO₂ injection integrity testing (courtesy Landline Ltd)

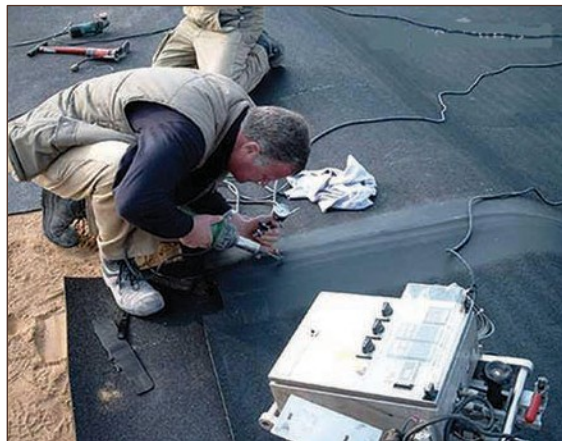
Figure A4.42 Air pressure testing (courtesy GSE Environmental)

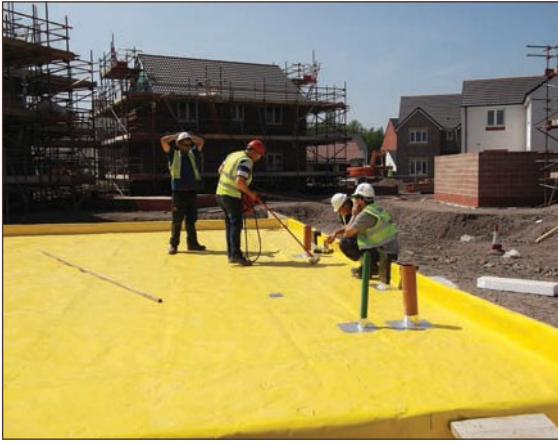
Figure A4.43 Dielectric porosity testing for housing scheme (courtesy NHBC)

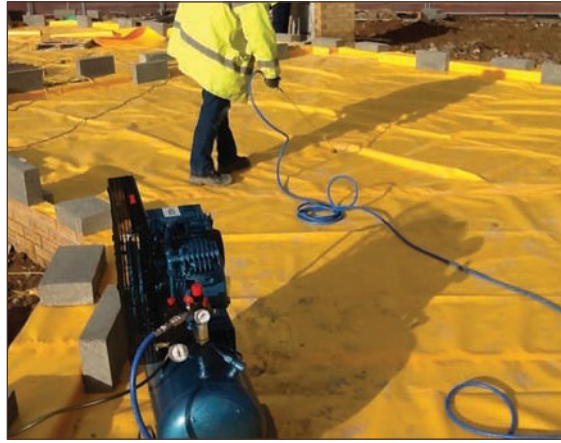
Figure A4.44 Air lance test, used to test the quality of welded seams along gas membrane joints (courtesy MEC Environmental Ltd)

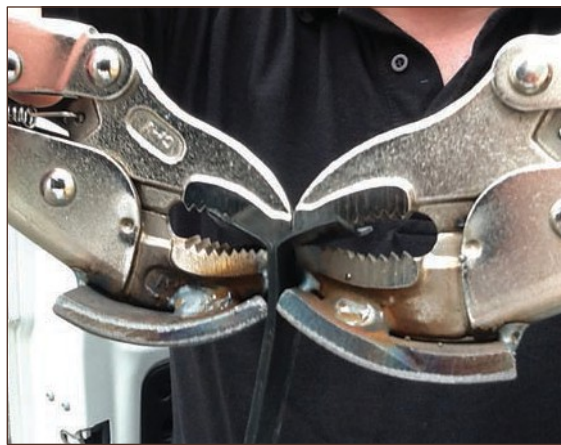
Figure A4.46 Testing a weld with 'dog bone' grips (courtesy MEC Environmental Ltd)

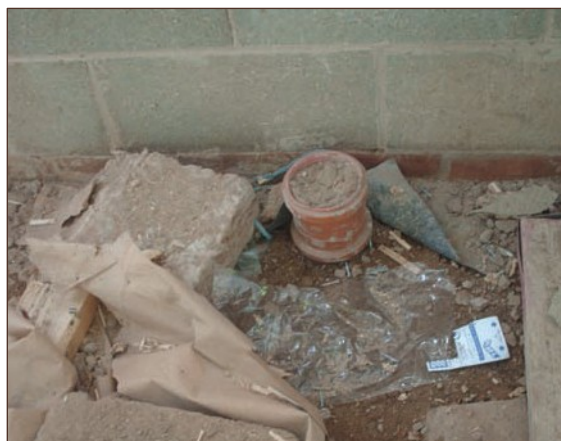
Figure A4.48 Loose nails and over construction debris likely to be left in place beneath gas membrane – poor preparation of gas membrane prior to sealing service penetration (courtesy Card Geotechnics Limited)

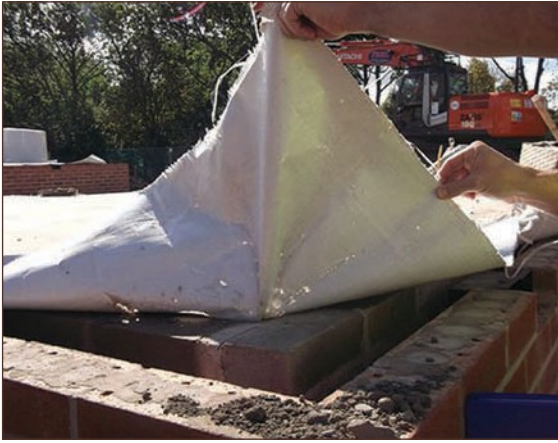
Figure A4.49 *Lifted gas membrane at corner position. Light penetrating through confirms damage to aluminium internal core layer (courtesy NHBC)*

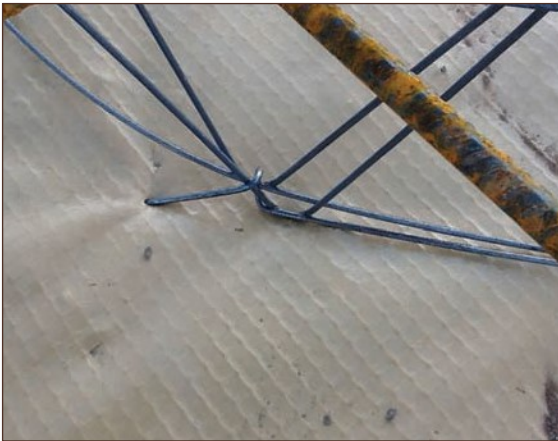
Figure A4.51 *Gas membrane torn by reinforcement (courtesy MEC Environmental Ltd)*

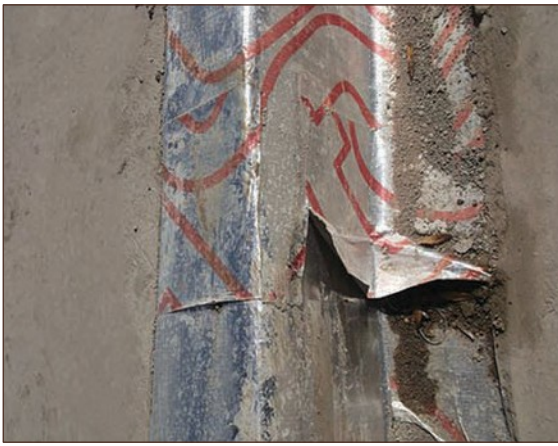
Figure A4.55 Gas membrane at stepped junction of slab to integral garage, appears to be susceptible to tearing when screed is poured. Screed may also weigh down on gas membrane if fitted too tight (courtesy NHBC)

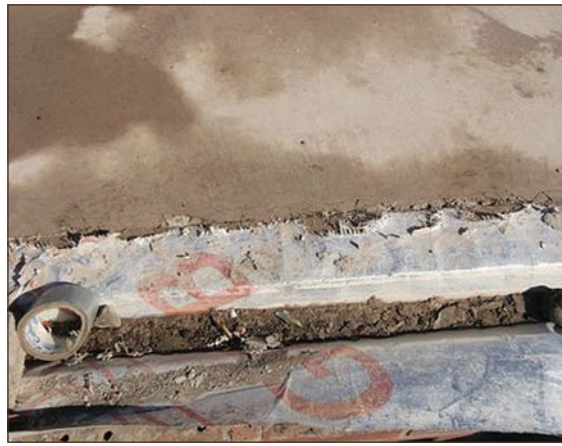
Figure A4.56 Gas membrane at edge of concrete screed. Screed has been grinded to achieve desired levels, gas membrane shows extreme wear and damage as a result (courtesy NHBC)

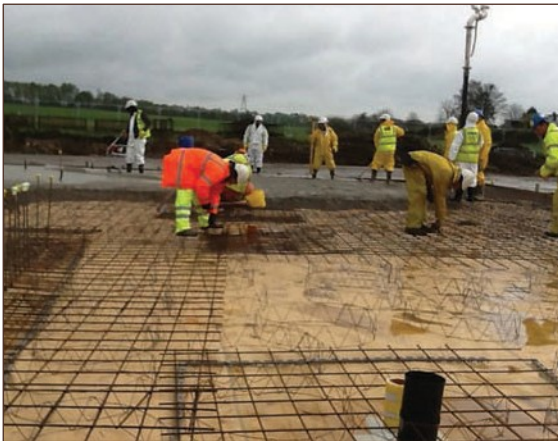
Figure A4.57 Unprotected gas membrane damaged by heavy traffic (courtesy MEC Environmental Ltd)

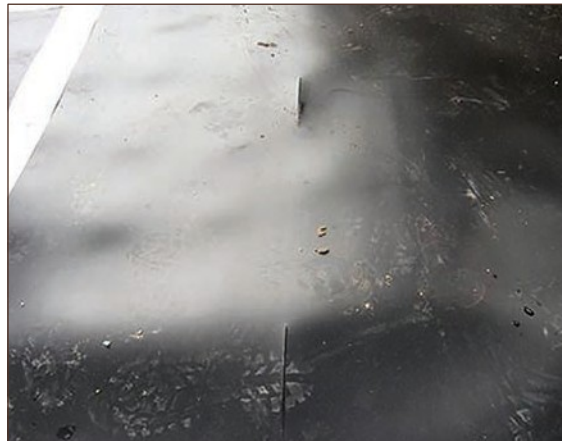
Figure A4.58 Damage caused to gas membrane by follow-on trade who cut/shaped the dry lining board directly on the unprotected installed gas membrane (courtesy NHBC)

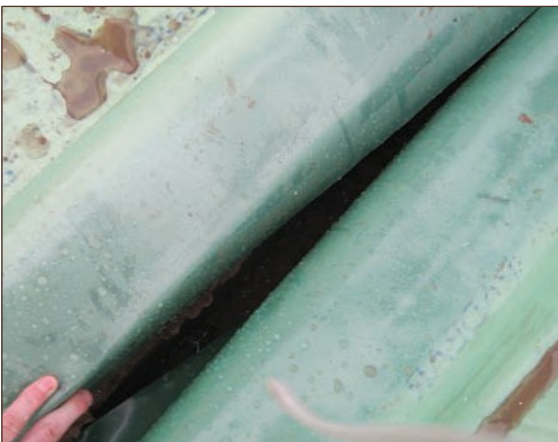
Figure A4.59 Gas membrane slit at the bottom of a cavity tray to enable water to drain away (courtesy Smith Grant)

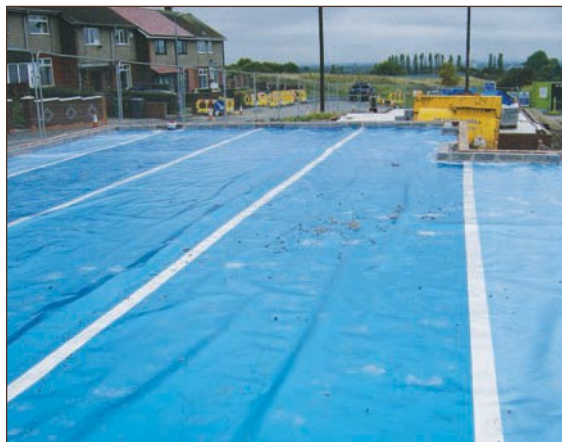
Figure A4.60 Some stones could penetrate gas membrane if sufficient force is applied (courtesy Smith Grant)

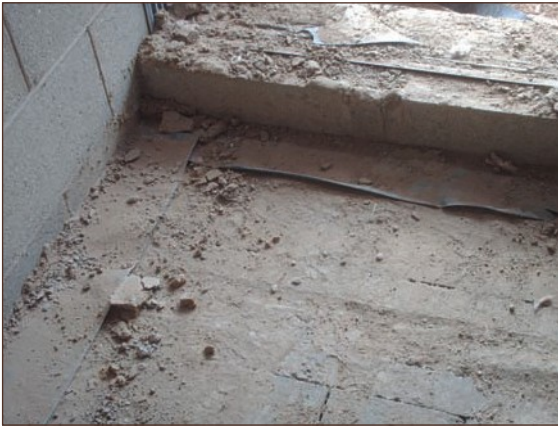
Figure A4.63 Absence of surface preparation prior to laying of gas membrane, debris likely to pierce gas membrane (courtesy Card Geotechnics Limited)

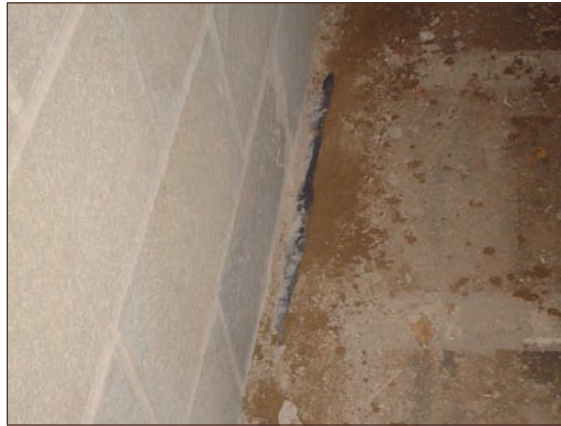
Figure A4.64 Insufficient length of gas membrane protruding through wall to overlap with gas membrane within building (courtesy Card Geotechnics Limited)

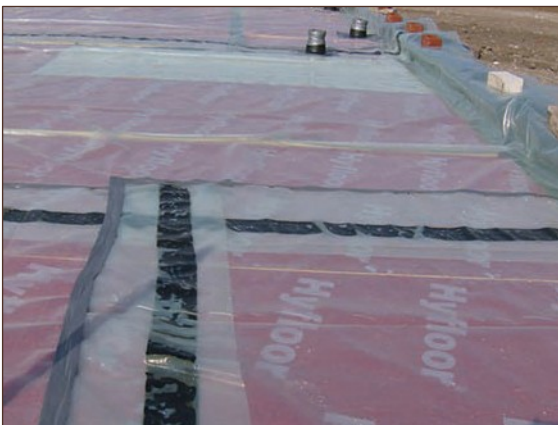
Figure A4.65 Wrinkling of gas membrane over joint has resulted in gaps (only visible due to the use of a transparent gas membrane) and the secondary seal uses ordinary gaffer tape rather than a proprietary product (courtesy Smith Grant)

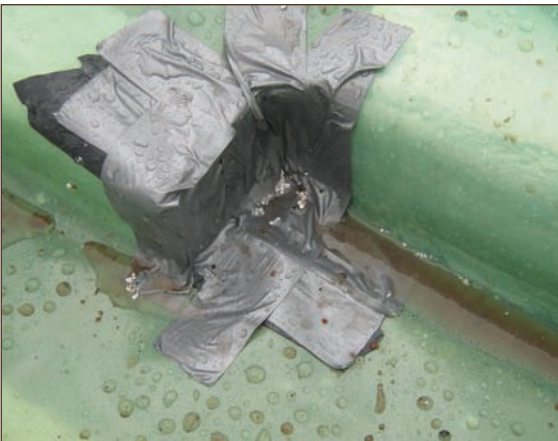
Figure A4.69 Attempt at corner detailing using non-proprietary duct tape (courtesy Smith Grant)

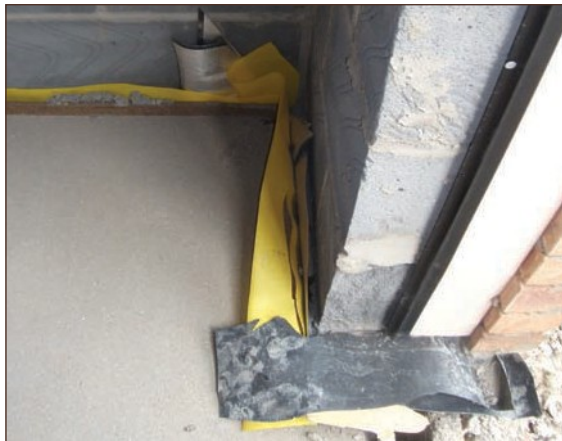
Figure A4.70 Inadequate corner detailing. The use of preformed proprietary products would have avoided such bad practice (courtesy NHBC)

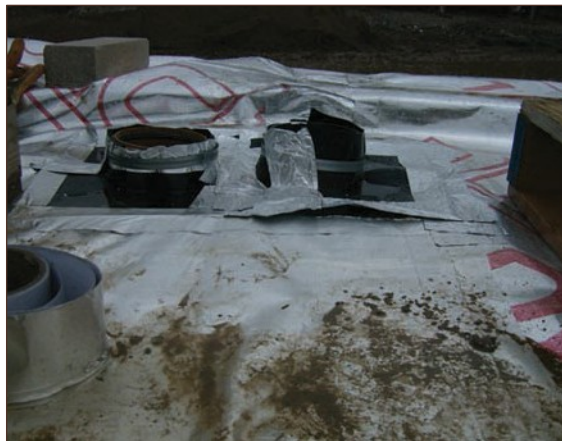
Figure A4.72 Joint between top hat and gas membrane has lifted due to poor fit and attempt to construct in very wet conditions (courtesy Smith Grant)

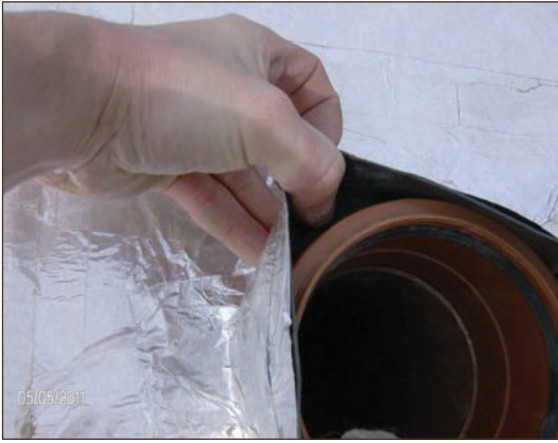
Figure A4.73 No bead of double sided butyl tape provided between interfaces of ID top hat and OD service pipe: cannot be compressed enough to form seal (courtesy Smith Grant)

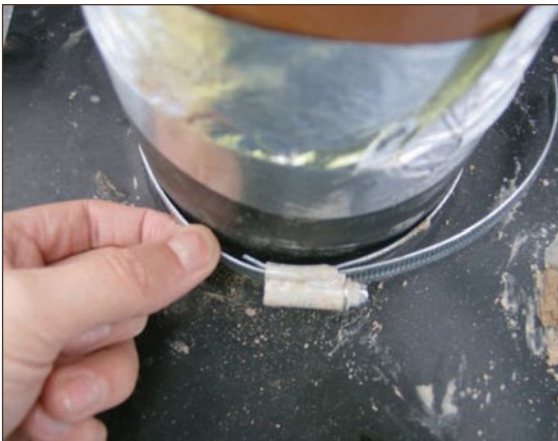
Figure A4.75 Jubilee clip on service entry insufficiently tightened so joint is uncompressed (courtesy Smith Grant)

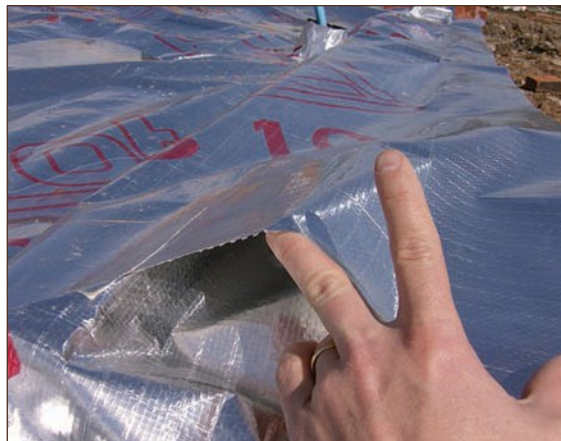
Figure A4.78 Gap in jointing over wall cavity big enough to insert fist (courtesy Smith Grant)

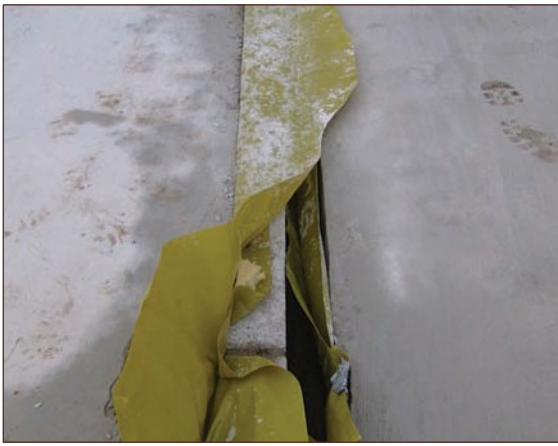
Figure A4.79 Gas membrane not continuous over internal wall. It had been deliberately cut open for unknown purpose (courtesy Smith Grant)

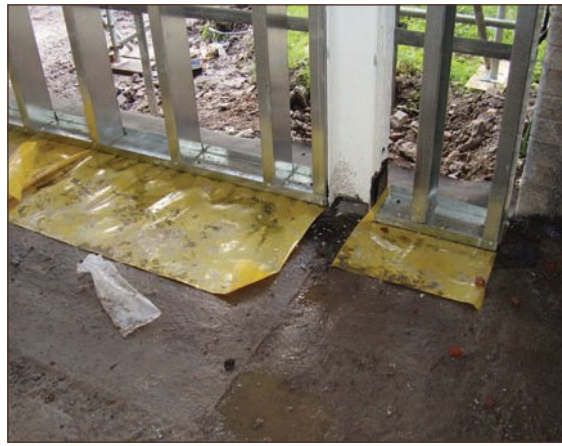
Figure A4.80 Column left unsealed (courtesy PAGEotechnical Ltd)

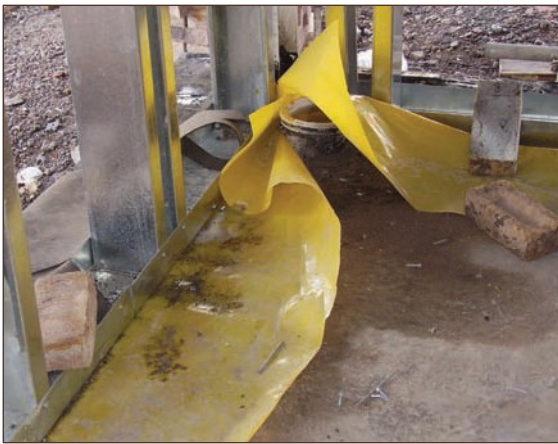
Figure A4.81 No seal to perimeter pipe (courtesy PAGEotechnical Ltd)

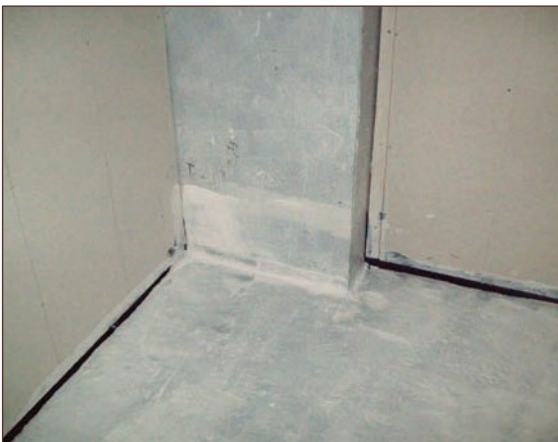
Figure A4.83 Poor quality installation of liquid gas membrane. Liquid gas membranes come in two colours (black and white) allowing coverage of each coat to be easily assessed. Here the gas membrane has been spread too thinly and inconsistently. In addition, it appears to have been applied to a damp surface, causing blistering (courtesy Card Geotechnics Limited)

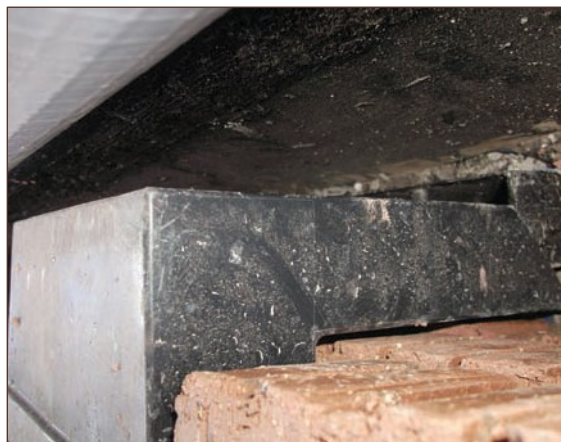
Figure A4.88 Ventilator becoming detached to fit to external block work. This is due to builders requiring increased cavity widths to achieve thermal properties expected by Building Regulations (courtesy NHBC)

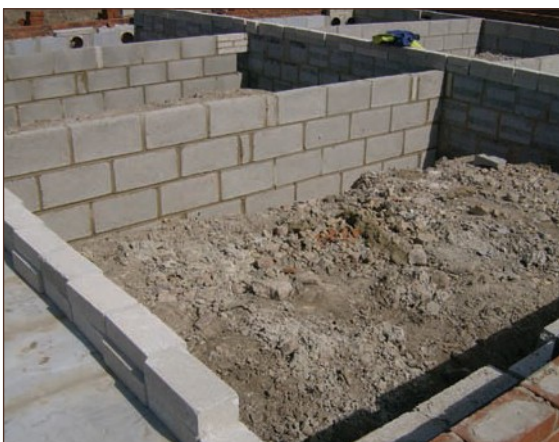
Figure A4.89 No ventilation in internal sleeper wall (courtesy Smith Grant)
